GRENFELL TOWER FIRE = A LOOK INTO THE ASPECTS OF “MINIMUM REQUIREMENTS” “RISK” AND “MODERN TECHNOLOGY” (BIM)

C. Gonzalez¹ and E. Voutsadakis²

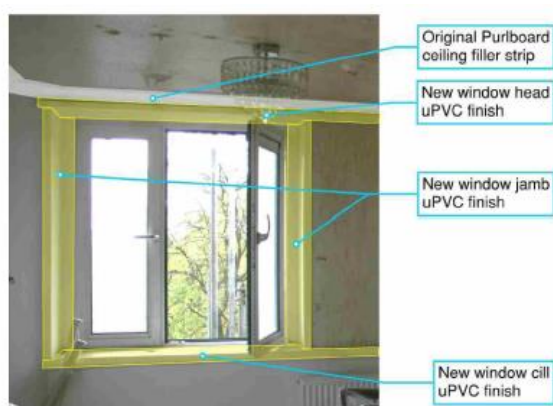
1. Figure1. Window internal new uPVC elements

Most of materials used in the new work carried out were combustible, (figure 1) therefore the egress and ingress of fire were facilitated by the removal of old windows, the installation of new windows shifted out some 185mm from the center-position of the old windows and the use of uPVC materials elements to fill the gaps produced by the new installations. (**Dr Barbara Lane's Expert Report. April 12, 2018**). The initial fire in the kitchen of flat 16, 4th floor affected the jamb and cills of the kitchen window and flames leaked out to the new combustible cladding. The fire rapidly spread vertically aided by the cavity between the insulation (Celotex RS5000) attached to the old concrete structure and the aluminum and polyethylene core composite material (ACM) Rainobond PE rainscreen. (**Prof. Jose Torero's Expert Report. May 23, 2018**).

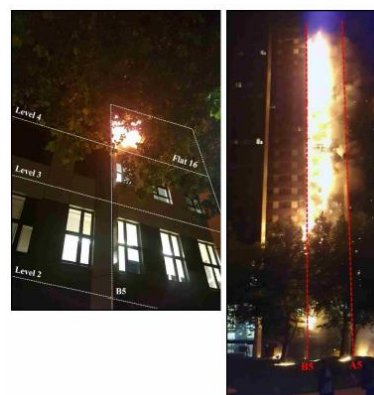
Figure 2: The origin of the fire in Flat 16, 4th floor + fast vertical spread of the flames

The initial fire in the kitchen of flat 16, 4th floor most likely affected the uPVC jamb and sills of the kitchen window and fire leaked out into the new combustible cladding installed two years earlier. (**Professor José L. Torero Expert Report. May 23, 2018**).

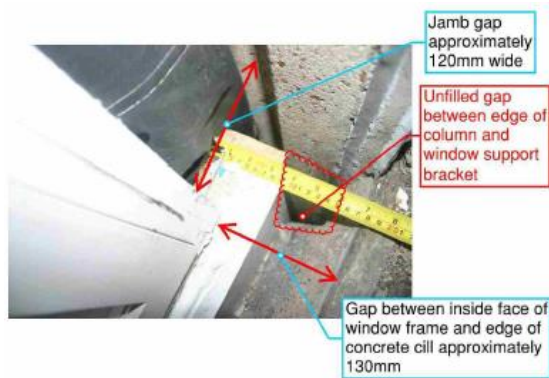
Figure 3: Gaps filled with Insulation and uPVC elements

CLADDING AND WINDOWS DETAILS; as seen in Figures 3 & 4 details, the design and workmanship of the installation of the new windows attached this time to the external cladding rather than to the old concrete fabric of the building was to create the combustible gap filled with combustible uPVC elements (Figures 1 & 5). These gaps in the fabric of the building, plus the design and materials of the curtain walling provides ideal conditions for fire and smoke to egress into the cladding and ingress back into de cellular spaces (flats) many times until most of the building was consumed killing 72 tenants.

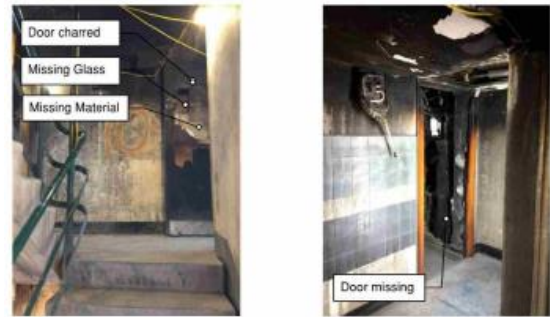
Figure 6: Damaged or missing flat door

FIREDOORS DETAILS: One of the unresolved mysteries is the fast spread of smoke and flames through the building bypassing two or three fire barriers; the exterior windows, the fire-rated entrance flat doors and the stairs fire doors.

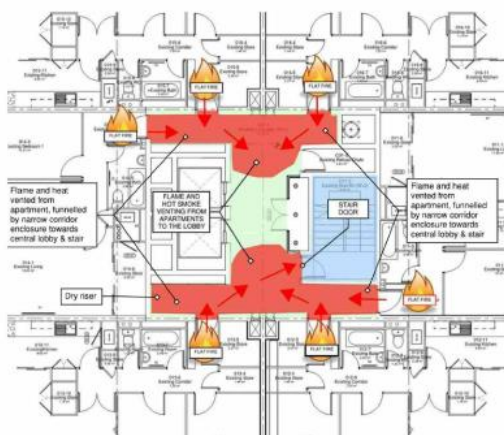
Figure 7 Compartmentation failure of the central corridor, stair well and lifts

EXITS AND ESCAPE ROUTES: One line of enquiry in the investigation process of Grenfell Tower fire is related to the two central aspects of cellular containment to the spread of fire that did not performed as envisage. Namely the failure of windows and fire doors to contain the spread of fire, inability to contain the toxic gases produced by combustion. The stair well was provide with positive air pressure to avoid smoke entering the space even when a fire door to stairs remained open. The work for that smoke extraction system was done before the refurbishment.

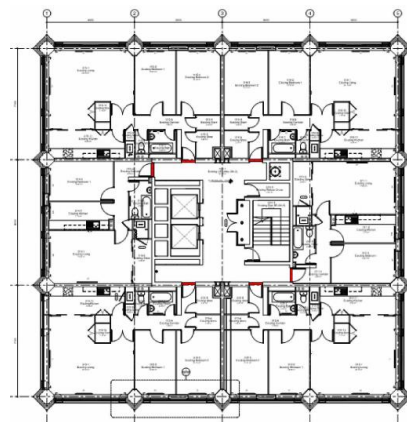
Figure 8 : Entrance to flats fire-doors in red
