A Comparative Study of Helicopter Planetary Bearing Diagnosis with Vibration and Acoustic Emission Data

Linghao Zhou, Fang Duan, David Mba
School of Engineering
London South Bank University
London, U. K.
Zhoul7@lsbu.ac.uk

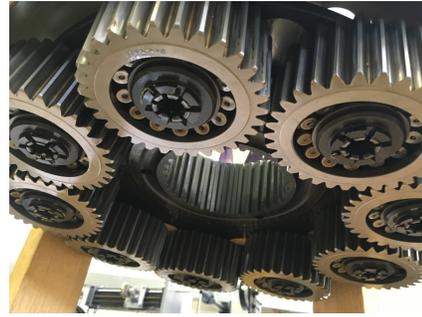
Figure 1. Demonstration of 2nd planetary gear/ bearing set

- Epicyclic Modules of MGB can achieve a large reduction rate of approximately 86:1 (calculated based on test rig MGB). Such functionality is realised by a sophisticated mechanical structure, which involves many planetary gears and bearings (see Fig. 1 and Fig. 2). This structure complicates signal transmission paths for accelerometers, hence vibration data collected are highly amplitude and frequency modulated, which potentially masks faulty signature.

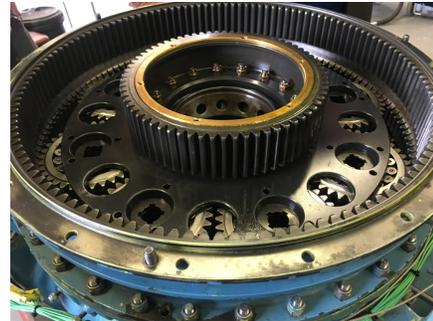
Figure 2. Demonstration of 2nd planetary sun gear and ring gear

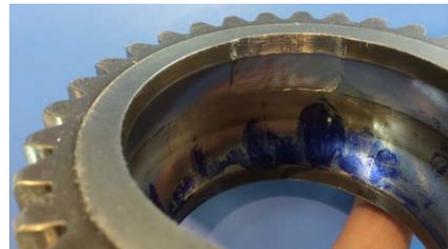
Figure 3. Major defect seeded at planetary bearing outer race

The MGB adopted in this test comprised of two epicyclic modules, a forward-module connected to a high speed DC motor, and an after-module that was left idle. 9 planetary bearings were installed at 2nd epicyclic module, and defects of two different sizes were planted at the outer race of planetary bearings (2nd planetary bearings are shown in Fig. 1), namely "minor defect" and "major defect", with dimensions of 10mm wide, 0.3mm deep and 30mm wide, 0.3mm deep respectively. The major defect was created that the defect range covered approximately 40° of the entire outer ring. An illustration of major defect seeded at planetary bearing is shown in Fig. 3. An adjustable load is added on top of MGB 2nd planetary carrier to simulate the main rotor.

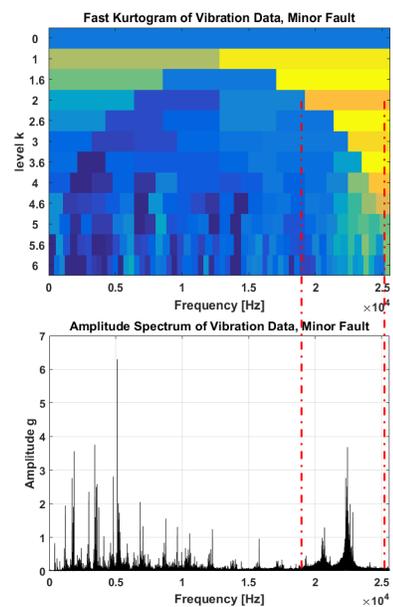
The kurtogram result suggested resonances at approximately 22000Hz centre frequency with 8000Hz bandwidth. By contrast, the same area in the amplitude spectrum showed structural resonances pattern. Envelope analysis using selected frequency parameters was performed

Figure 4. Kurtogram of vibration data, incomparison of FFT, minor fault

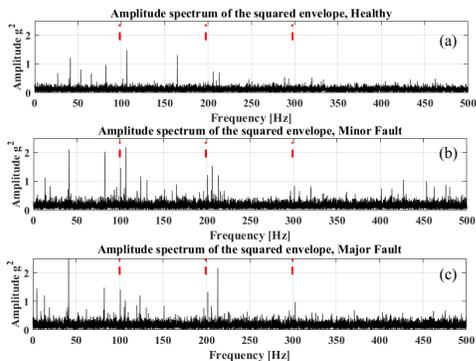
Figure 5. Vibration Envelope analysis results, (a) Healthy (b) Minor Fault and (c) Major Fault

It is evident that under healthy condition, very tiny frequency components near 100Hz can be observed, no corresponding 2nd and 3rd harmonics of such frequency can be observed. In both minor fault and major fault condition, distinctive 100Hz BPFO components can be identified, as well as the 2nd and 3rd harmonics, indicating a fault related signal signature.

Nonetheless, disturbing frequency components and harmonics were still obvious in Fig. 5. For example the strong 106Hz frequency components existed in all three conditions. This suspicious frequency and its sidebands, harmonics can hinder the accuracy of fault detection under low SNR conditions.

The diagnosis regarding commercial MGB with seeded defects was successful using kurtogram and envelope analysis. However, AE data have shown some great features compared with traditional vibration data. According to Fig. 5 and Fig. 7, AE data were less sensitive to the modulation from 2nd epicyclic carrier speed and gear meshes, which showed the superiority of the AE system installed. Also AE results revealed the severity of defects, which was not reflected in vibration data processing results. The high frequency content of AE naturally blocked the interferences from ambient noises, which potentially increased SNR and benefits fault diagnosis. In summary, AE signal monitoring technique has potentials to improve HUMS detection capability for bearing defects.

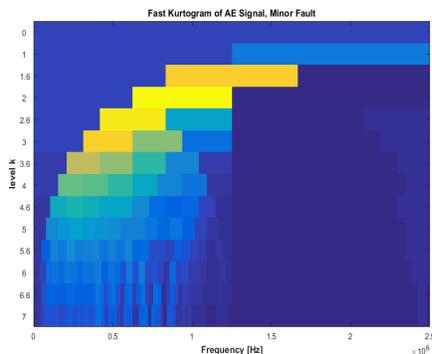
Figure 6. Direct kurtogram of AE signal

Similar processing routine was applied at AE data. The results are shown below:

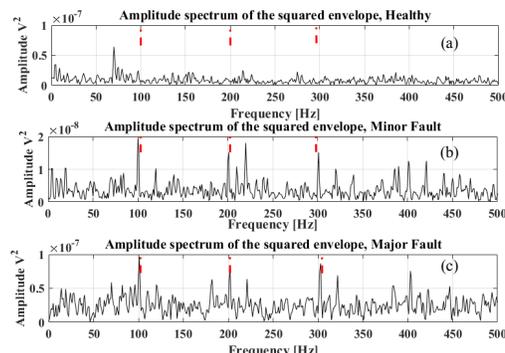
Result in Fig. 7 suggested a clear indication of faulty BPFO frequency components near 100Hz in both minor and major condition. BPFO and its 2nd and 3rd harmonics in AE envelope

analysis results were dominating. No suspicious frequency components were large enough to affect the identification of defects; moreover, the defect severity progress was also reflected as BPFO of major defect was significantly larger than that of minor condition.

Figure 7. AE Envelope analysis results, (a) Healthy (b) Minor Fault and (c) Major Fault
