# Enhanced TDR Technique for fault detection in Electrical Wires and Cables

G.H. SHIRKOOHI, K. HASAN

Department of Engineering & Design

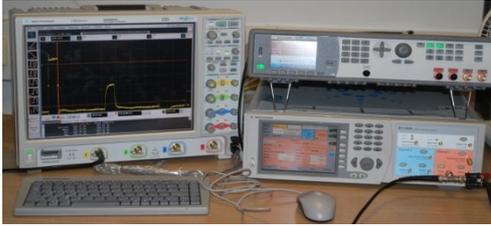
Figure 1 shows the experimental setup used in the measurements, Agilent 81134A 3.35 GHz Pattern Generator and Agilent 4 GHz, 20GS/s Infiniium oscilloscope (MSO9404A). An Agilent 81150A 120 MHz arbitrary waveform generator (the instrument

on the top right in figure 1) was initially used to synchronise the 3.35 GHz generator and the 4GHz Infiniium scope with each other, and was not used in the measurements. Figure 2 shows the selected position (marked by brown tape on the floor), for creation of the arbitrary Fault which was chosen to be at around two meters from the end of the six meter long cable under test.

Figure 1. The experimental setup, Agilent Pattern Generators and Infiniium oscilloscope.

An Agilent arbitrary pattern generator (81134A 3.35 GHz) was used to generate and launch the successive pulses into the cables. The reflected waveforms were then captured using an Agilent 4 GHz, 20GS/s Infiniium oscilloscope (MSO9404A). The Agilent pattern generator and oscilloscope were used in conjunction with a PC workstation in order to demonstrate this technique for the detection and locating damage to insulation and braiding in a coaxial cable. The insulation damage was created at an arbitrary position along the wire. The fault consisted of a 1.0 cm (10 mm) cut created on the insulation and braiding of an RG59 coaxial cable of a total length of six metres. This fault was created on one side of the cable in a position between the centre and the end of the cable. The central core conductor of the coaxial cable remained undamaged. This flaw which was created at around two thirds of the way down from the beginning of the cable was successfully detected using the ETDR technique.

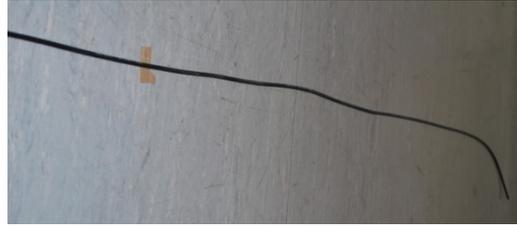
Figure 2. The selected position for the creation of the fault at two meters from the end of the six meter long cable.

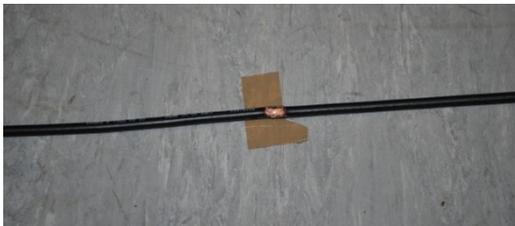
Figures 3 and 4 show the position, shape and size of the 10 mm fault created in an RG59 coaxial cable of an overall length of six metres. This defect was created on the insulation and braiding on one side of the cable. The central core conductor of the coaxial cable remained unaffected.

Figure 3. Fault created at around two meters from end of the six meter long cable (the position shown in Figure 2).

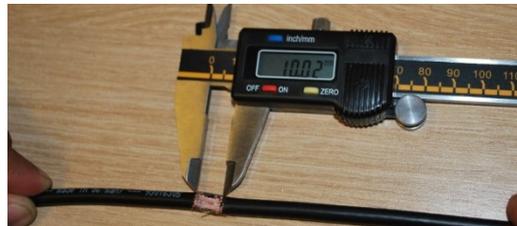
Figure 4. Shape and size of the 10 mm fault created on the insulation and braiding of an RG59 coaxial cable.

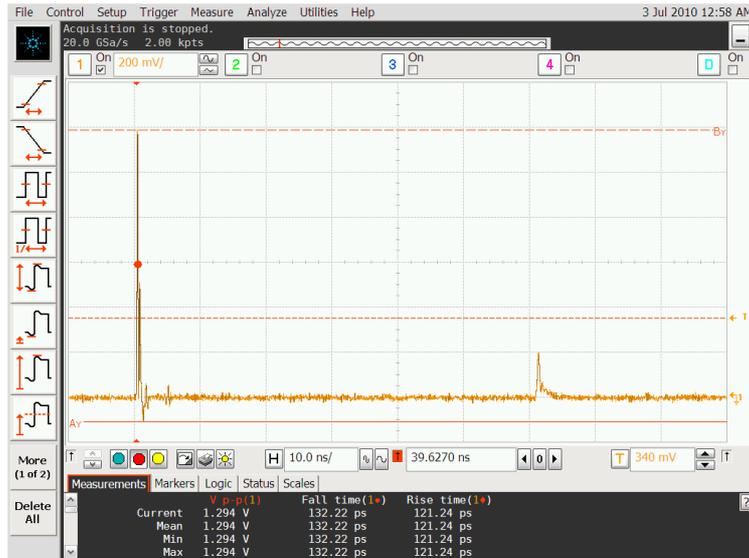
As mentioned, the technique involves injection of a large number of pulses of varying size into the cable under test which span over 5, and in some cases 10 nanoseconds. The analysis of these pulses is then carried out which will provide the anomalies due to the defects to be detected. Figure 5 shows the reflection trace for a test pulse, observed on the Agilent 4 GHz, 20GS/s Infiniium oscilloscope, with rise and fall times of around 132 and 121 picoseconds respectively. A positive reflection from the end of the cable is also seen, which was an open circuit in this case.

Figure 5. Captured image of a test pulse with rise and fall times of around 132 and 121 picoseconds respectively showing a positive reflection from the end of the cable (which is open circuit in this case).

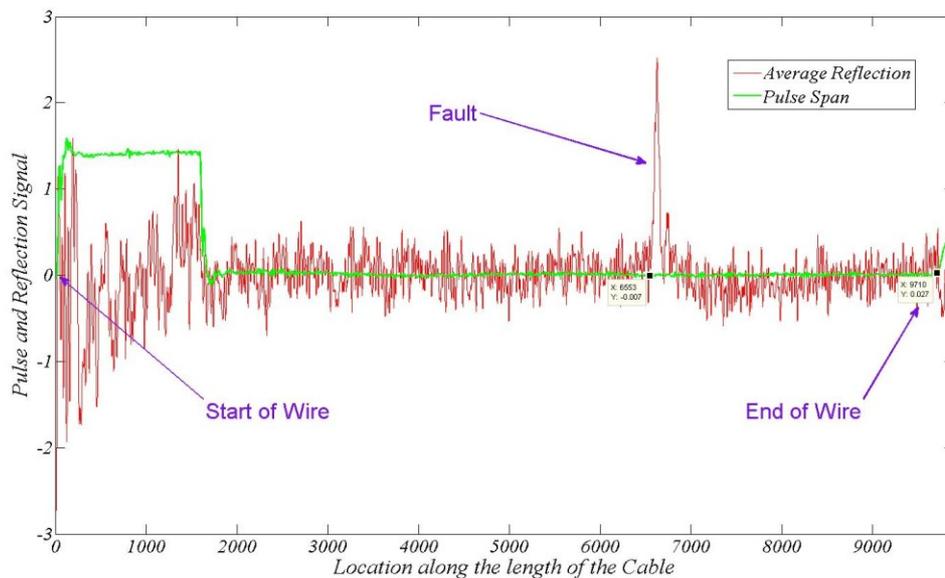
Figure 6 shows analysis of the results obtained for the six metre long RG49 coaxial cable with a 10 mm fault created on the insulation and shielding screen of at around two thirds of the distance from the beginning of the cable where TDR pulses were being injected into the cable.

Figure 6. Analysed results for the detection of a 10 mm fault created on the insulation and shielding screen at two thirds of the distance down a six metre long coaxial cable. The large spike in the trace is due to the fault.

The figure shows the analysed reflected signals from the cable, which starts from point zero on the horizontal axis, as indicated in the figure, coinciding with the rise of the green trace, representing the pulse span. The pulse span describes the width within which all injected pulses are contained. The end of the cable can also be determined by the rise of the pulse span trace when the pulses are reflected from the end of the cable, which was an open circuit in this case. In real terms, the TDR traces show a distance equivalent to that of twice the time of flight to the end of the cable, since the measurements are carried out at one end of the cable under test, and the time taken for the reflection signal to reach the detector would have to cover the length of the cable, and its return back to the detector. The pulse span itself, in this case, is the period of time where multiple pulse lengths are launched into the cable and hence cannot be included in the measurements. A 10 ns time span is generally the time of flight in around one metre for most of the wires and cables. In this case the fault was created at around four metres down from the start of the cable. The position of the fault is shown as indicated in the figure, as a large spike. This spike is clearly seen to be well above the measurement noise along the axis.

An experimental technique has been developed for detection of small faults over long lengths of wires and cables. The technique uses injection of successive pulses with sharp rise and fall times, and with higher pulse spans of up to around 10 nanoseconds into the cable, in order to detect small faults over longer distances. The technique has been used to accurately detect the position of a 10 mm fault created on the insulation and braiding on one side of a six metre long coaxial cable.
