# FAULT DETECTION IN AIRCRAFT WIRING USING ENHANCED MULTI-PULSE TDR TECHNIQUE

**Abstract.** Defects in electrical wiring could result in disastrous consequences especially in airborne systems. The defects may in many cases be due to minor damage in the insulation or shielding of wires and cables. This type of defect is not usually detected using routine testing. They may be caused by vibration, moisture, heat, cold, abrasion and other similar effects, causing frays and cracking in wire insulation. Degradation and failure of aircraft wiring insulation is of particular interest which could lead to smoke and fire due to arcing. Results of a technique based on TDR, using trains of successive pulses was previously presented and confirmed through modelling of cables. In this paper the investigation is extended to include small 10 mm and 5 mm holes in coaxial and shielded twisted pair cables. The technique is easy to establish and due to its cumulative nature, can provide higher accuracy with increasing incremental steps. It also holds promise for detection of stray fields for non-contact detection of faults, particularly in shielded cables and wires.

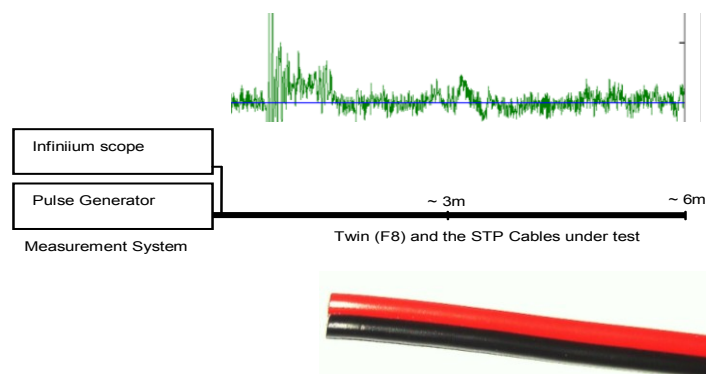
Figure 1. Experimental setup for measurement of the 6 meter long figure-of-8 twin conductor power cable and the shielded twisted pair (STP) cable, using the Agilent 81134A 3.35 GHz Pattern Generator, and Agilent 4 GHz, 20GS/s Infiniium oscilloscope (MSO9404A).

Figure 1 shows the experimental setup used in the measurements, Agilent 81134A 3.35 GHz Pattern Generator and Agilent 4 GHz, 20GS/s Infiniium oscilloscope (MSO9404A). This figure shows a defect created at the centre of the six metre long cable under test, for the twin cable displayed at the bottom of the figure. The result obtained from measurement is shown as the green trace, corresponding to, and above the physical layout, showing the

fault signature at around 3 metres. Same physical arrangement was used for the STP cables, not discussed here.

Figure 1 also shows the ETDR response for a six metre long twin conductor (figure-of-8) Cable with 10mm fault on one wire insulation, at a distance of 3 metres in the middle of the cable. The results in this figure show a distinctive change in the incremental variation of the analysed data along the length of the cable, corresponding to the position of the fault near the centre of the cable. This was also confirmed through computer models of the fault, using FDTD simulation software [20]. The cumulative incremental nature of the analysed measurement results provides a highly averaged data set, which eliminates the need for experimental repetition of measurements, in order to obtain reliability for the technique. The figure shows that variation of the signal is not uniform along the length which depicts the small fluctuations in the localised impedance, which can be attributed to the local stresses and the very small bends in the conductors. The effect from the defect is clearly visible and is seen to be different from that of the measurement noise. The signature for the

defect in this case is seen to consist of a distinctive rapid change in the reflection signal in the middle of the cable. At first glance, the region of the negative slope corresponding to the defect is seen to begin with positive peak and end with a negative one. The figure shows the analysed reflected signals from the cable (upper trace in the figure), which starts from point zero on the horizontal axis, as indicated in the figure. The end of the cable is also easily determined by the rise of the pulse trace when the pulses are reflected from the end of the cable, which were open circuits in all the cases presented in this paper. In real terms, the TDR traces show a distance equivalent to that of twice the time of flight to the end of the cable, since the measurements are carried out at one end of the cable under test, and the time taken for the reflected signal to reach the detector would have to cover the length of the cable, and its return back to the detector. The technique was previously described in detail [19, 20]. A 10 ns time span is generally the time of flight in around one metre for most of the wires and cables. In these results additional noise at the beginning of the measurement traces are observed in all displayed results. This was explained in previous reported work, and is briefly explained later (see pulse span trace in figure 5).

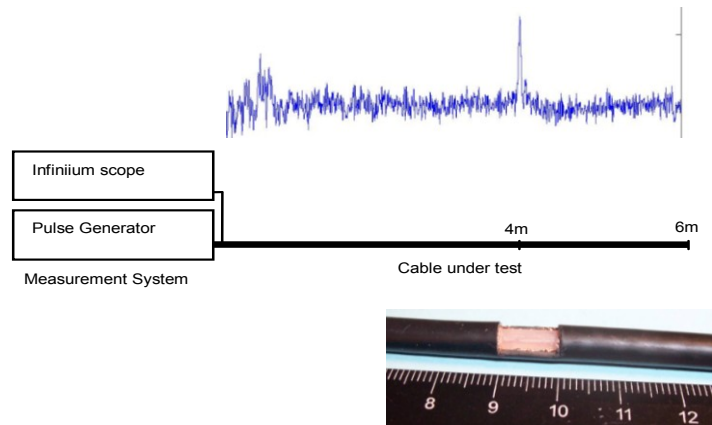
Figure 2. Experimental setup for measurements the 10 mm defect in the insulation and shield of the 6 meter coaxial cable.

The 10 mm defect in a six metre long RG-59 coaxial cable is presented next. As mentioned, this fault was created on one side of the cable in a position between the centre and the end of the cable, at 2 metres from the end of the cable. Figure 2 shows the experimental setup, the fault detail and the results obtained for a 10 mm defect in the insulation and shield of the 6 metre coaxial cable. The figure also shows the profile of the 10 mm fault created in an RG-59 coaxial cable. The defect, as shown, includes cut in insulation, shield and dielectric core on one side of the cable. The central core conductor of the coaxial cable remained intact [19]. The upper trace in the figure shows analysis of the reflection results obtained for the cable, where the incremented pulses of up to 10 nanoseconds were injected into the cable. The figure shows the analysed reflected signals from the cable, which starts from point zero on the horizontal axis. As described earlier the fault was created at around four metres down from the start of the cable. The position of the fault is identified as indicated in the figure, as a large spike in the results obtained from the analysis of incremental pulse reflections. The signature for the defect in this case is seen to consist of a distinctive sharp peak in the reflection signal in the region corresponding to the defect location along the cable. This spike is clearly seen to be well above the measurement noise along the axis. Although the cumulative incremental reflected results shown in both figures 1 and 2 are seen to be generally adequately large, because of the summation nature of the technique, those presented in the latter are seen to be much more prominent due to the characteristic

nature of the coaxial cable in comparison to that of the straight parallel conductors. The technique hence, seems to be much better suited to shielded cables. The detection of the defect in the coaxial cable, described above, shown in Figure 2, was very decisively made. Following the successful detection of this 10 mm cut on one side of the coaxial cable, a set of more subtle defects were considered. In order to investigate a defect corresponding to a small hole, a 5 mm defect was created in the insulation and on the shield, on one side of the RG-59 cable, where the internal dielectric and core conductor remained intact. This was then carefully enlarged to a 10 mm defect of the same structure for confirmation of the results. Figures 3 and 4 show the configuration for the 5 mm and 10 mm cut in the sleeve and shield, corresponding to small hole in the RG-59 cable. These defects were again created at around 4 metres from the start of the cable under test. The cable was then subjected to the incremental pulse procedure associated with the ETDR technique. Figure 5 shows the result of analysis of the ETDR response for the cable where the positions of defects are clearly visible at a distance of around 4 metres from the start of the cable. In order to compare the result of analysis for these two defects, their corresponding cumulative reflection results were superimposed in two different colors. The result obtained for the cable with the 5 mm defect in the cable shield shows a much smaller amplitude at fault location than that of the cable with 10 mm

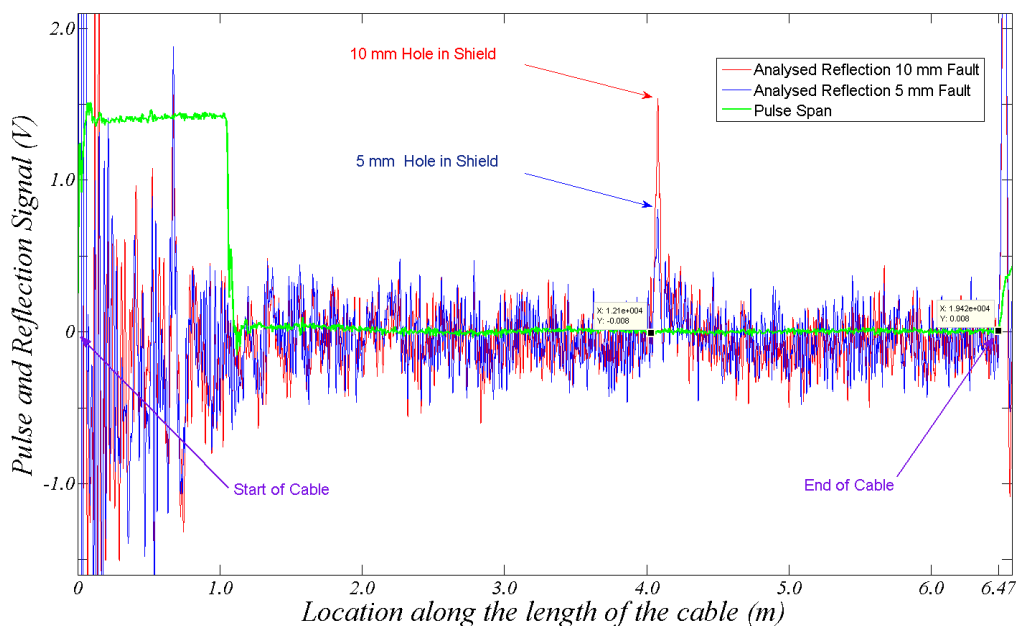
Figure 5. ETDR response analysis for RG59 coaxial Cable with 5 mm and 10 mm on its shield and insulation at a distance of around 4 m of a 6.47 m long cable.

fault, as would be expected. The position of the defects is also clearly observed to be at the same distance from the start of the cable, again as expected. The most significant difference in the fault signature for the two is the difference in the amplitude of the two signals.

The figure also shows that the amplitudes for the detection of this type of defects as small as 5 mm can be seen to be significantly larger than the noise level, and since the method is cumulative in nature, the amplitude corresponding to the defect would only increase further with increasing the number of increments. Initial impression from the results obtained for the three similar types of faults presented here for the coaxial cable all indicate a prominent sharp spike at the region close to the location of the actual fault. The straight pair of parallel conductor cable does not exhibit a similar effect. This is expected since the topology of the impedance for the two is quite different. In simple terms for one, the capacitive effects are very dominant in the coaxial cable.

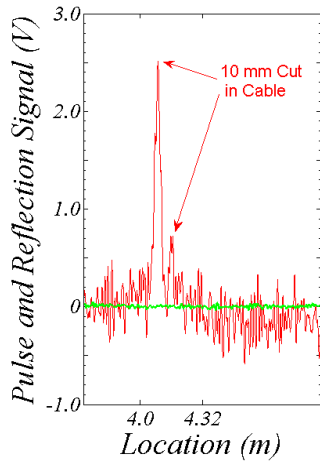
Figure 6. The detail of reflection effects for the 10 mm cut created on the insulation and shield of the RG59 coaxial cable.

Figure 6 shows the close up of the defect signature for the 10 mm cut in the RG-59 cable, shown in Figure 2. The cumulative reflection for this defect shows a prominent spike followed by a much smaller one. The second spike is so much smaller that it falls well within the noise level. However, it is very important to examine this as far as possible, since cumulative effect giving rise to the two spikes is due to the reflection effects from the two edges of the defect and if achievable, it could lead to precise characterization of the defects. Same trend is also evident in the results shown for the small 5 mm and 10 mm shield defects presented in Figure 5. A close up of the fault reflection signature for these is shown in Figure 7, where the second peak for both color coded signals are clearly identified, although because of the small size of the defects, these second spikes are seen to be far too small and well inside the noise level. The investigation was extended to include the effects of shield defects in the shielded twisted pair (STP) cables. This was carried out by creating a defect corresponding to a small

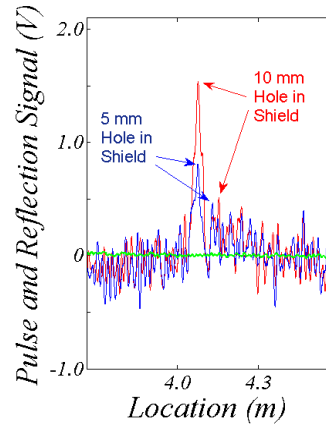
Figure 7. The detail of reflection effects for the 5 mm and 10 mm defects created on the insulation and shield of the RG59 coaxial cable.

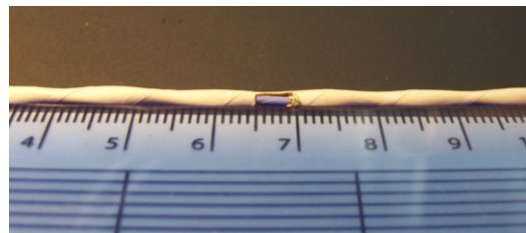
Figure 8. Defects of 5 mm hole created in the outer insulation and on the shield, on one side of the twisted shielded pair cable.

hole, where a 5 mm defect was created in the outer sleeve and on the shield, on one side of a shielded twisted pair cable, where the internal conductors remained intact. This was then carefully enlarged to a 10 mm defect of the same structure, in order to investigate the defects in a similar manner to those of the RG-59 cable, and for confirmation of the results. Analysis of these is currently in progress and will be published once the simulation models are also fully constructed and analysed. It should be noted that the STP 3D models have proved to be much more complex to construct. Figure 8 shows a Defect of 5 mm (hole) created in the outer insulation and on the shield, on one side of the shielded twisted pair cable.
