Causes, Consequences and Prevention of Fires in Domestic Refrigeration Systems

**A thesis submitted in partial fulfilment of
the requirements of London South Bank
University for the degree of Doctor of
Philosophy**

**This research programme was
carried out in collaboration with
the London Fire Brigade**

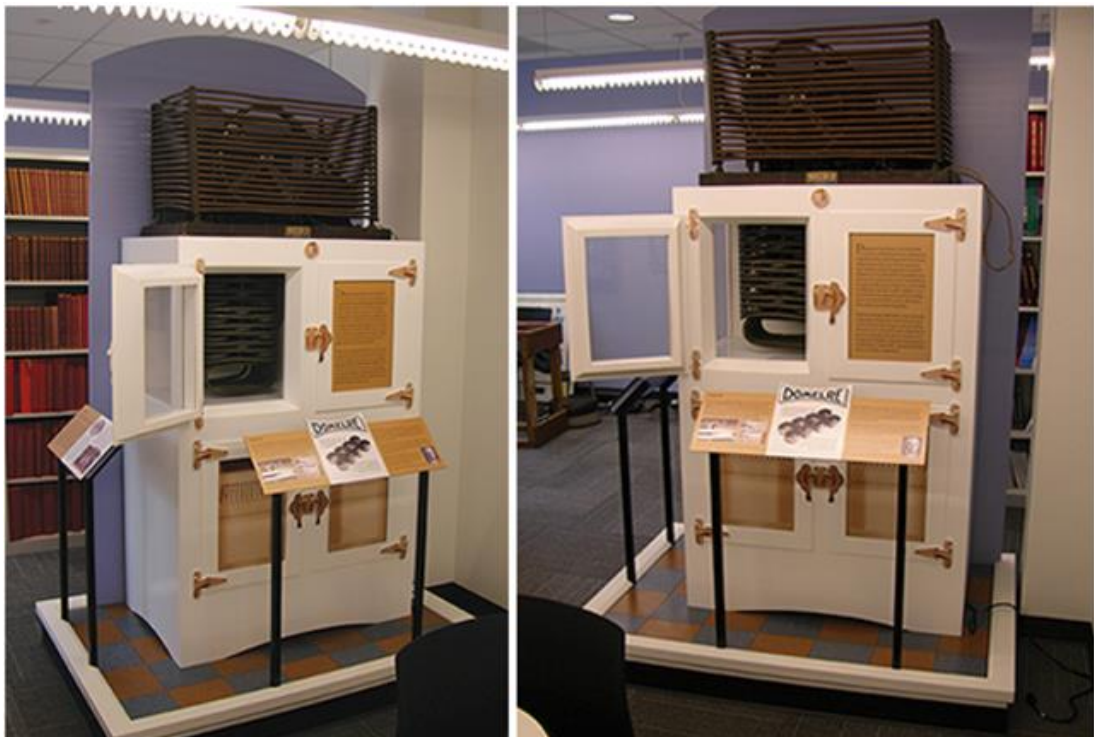
Figure 2.1 The Domelre - Domestic Electric Refrigerator (Chapman, 2010)

Fred W. Wolf Jr is attributed with producing the first commercially viable electric refrigerator - the DOMELE - in the United States, in 1913 (Figure. 2.1). This appears to have been a conversion, rather than a totally new product, consisting of an icebox with an air-cooled refrigeration attached to the top (Hertzman 2016)

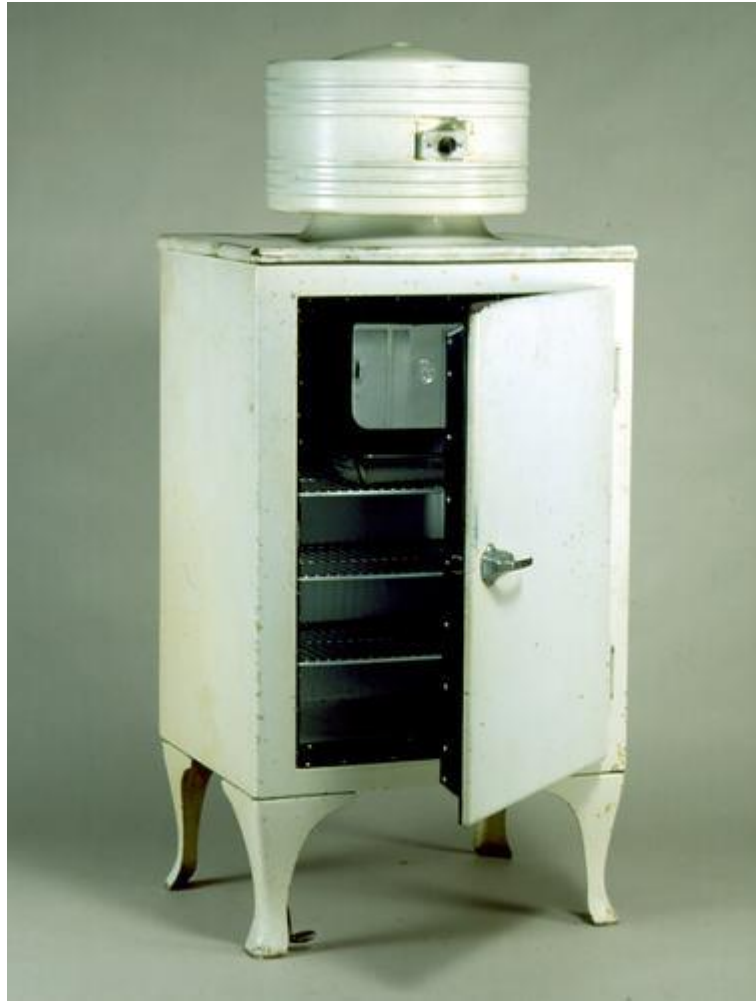
Figure 2.3 A monitor top refrigerator produced by General Electric in 1927.
(Smith C. 2005)

Mass production of individual appliances slowly replaced these communal 'ice box' systems. The successful designs such as the popular monitor top refrigerator range (Figure. 2.3), with their top mounted compressors sold in large numbers, with the base mounted compressor developed towards the end of the decade. A simple monitor top refrigerator requires at least four persons to lift it.

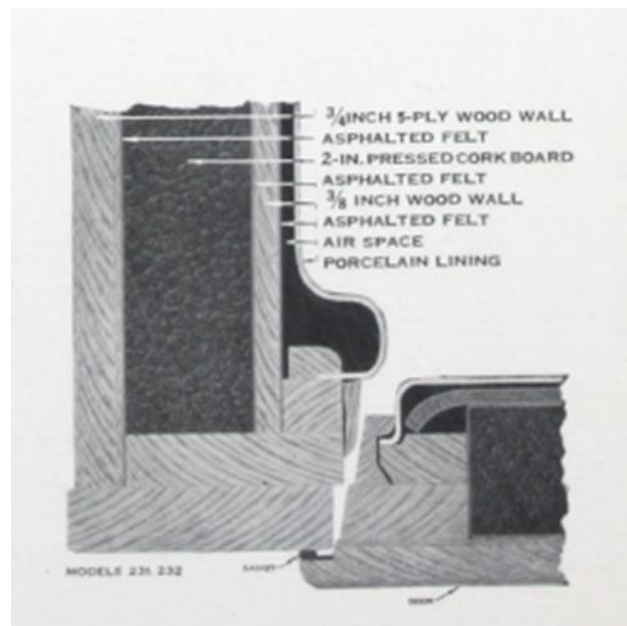
Figure 2.4 Cross-section illustrating the insulation materials used for the side-wall and door in a 1920's Kelvinator refrigerator (Kelvinator Corporation, 1926)

The early mass-produced appliances used insulating materials such as cork and felt and even employed chipboard and timber illustrated in Figure 2.4.

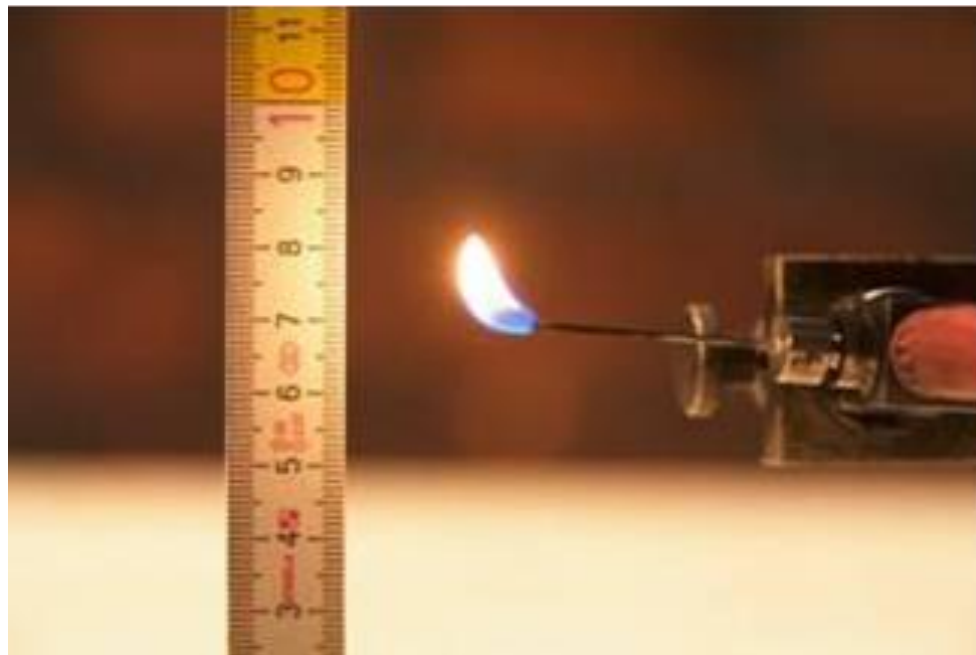
Figure 2.10 The IEC TS 62441 needle flame test
Beard and Goebelbecker (2007)

ignited using an International Electrotechnical Commission, IEC TS 62441 needle flame. Fig 2.10 (safeguards to reduce the likelihood of room flash-over as a result of accidental ignition of exterior housings of audio/video and information communication technology products likely to be used in the home) The flame was applied to the right-hand side of the rear wall of the compressor compartment. The flame is to replicate an accidentally caused candle flame ignition. The resulting fire was allowed to burn, without any suppression being applied, for over 30 minutes. The peak heat release rate measured during the fire test was 852 kW. On the basis of the tests, they concluded that small flame ignition sources could pose a definite risk to household appliances like refrigerators.

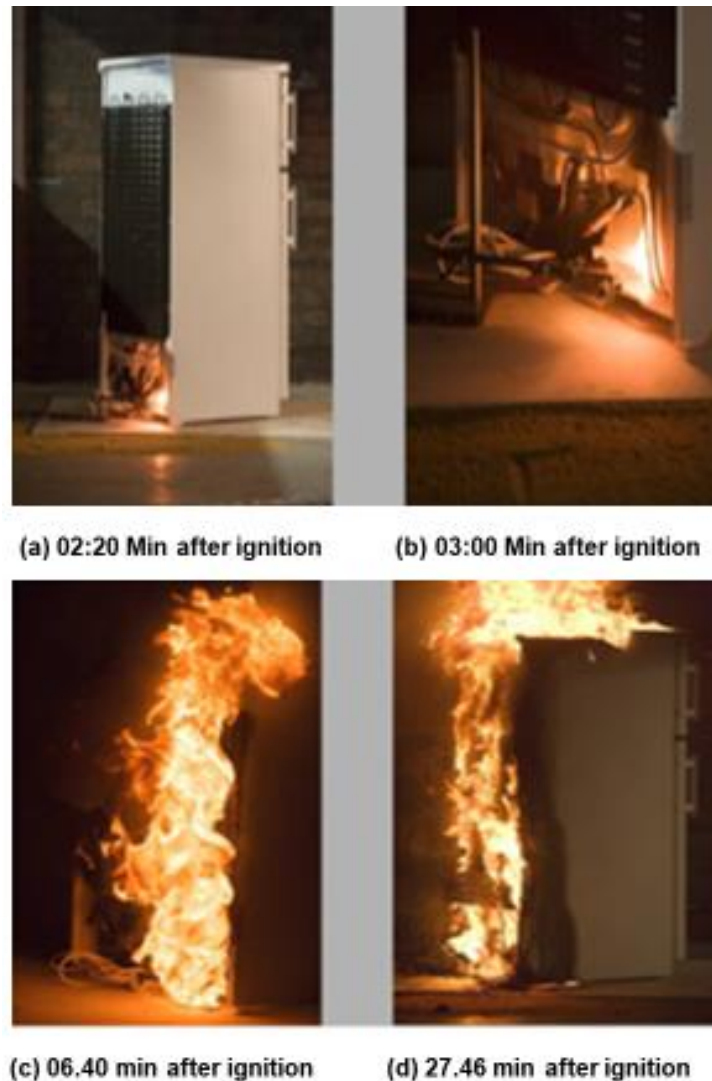
Figure 2.11 Fire sequence following ignition of fridge Beard and Goebelbecker (2007)

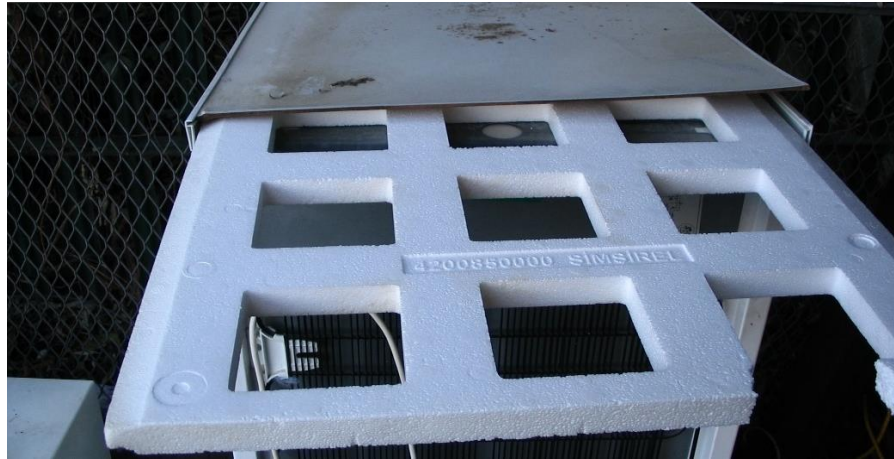
Figure 3.1 Polystyrene panel used in refrigerator construction.

Part of this research project also involved regular visits to local authority re-cycling yards where permission had been given to examine refrigeration appliances, prior to their disposal. The appliances were placed in the yards for forward transfer, to be re-cycled at the designated government re-cycling centres. No history was available for any service or fault issues. The appliances covered at least the previous three decades and provided a good insight into the construction processes and material changes that have taken place. Some appeared to have been stored for a period before disposal whilst others still contained ice in areas such as the freezer section, confirming their recent use prior to disposal. It was evident that comparisons between earlier and more modern dated appliances showed a clear and progressive switch from metal and timber, to plastic construction. A difference in general construction weight was also noted with a significant reduction in more modern appliances compared to similar sized earlier examples. Where possible observations of construction materials were photographed such as figure 3.1 providing detail of changing trends. The panel located directly beneath a thin, hardboard top of this appliance has been constructed of polystyrene. The panel could be used for its insulating properties but since it contains a number of large holes, its use is probably to provide the cheapest form of rigidity to the top panel above. The material will burn rapidly once ignited and will quickly assist the spread of fire.

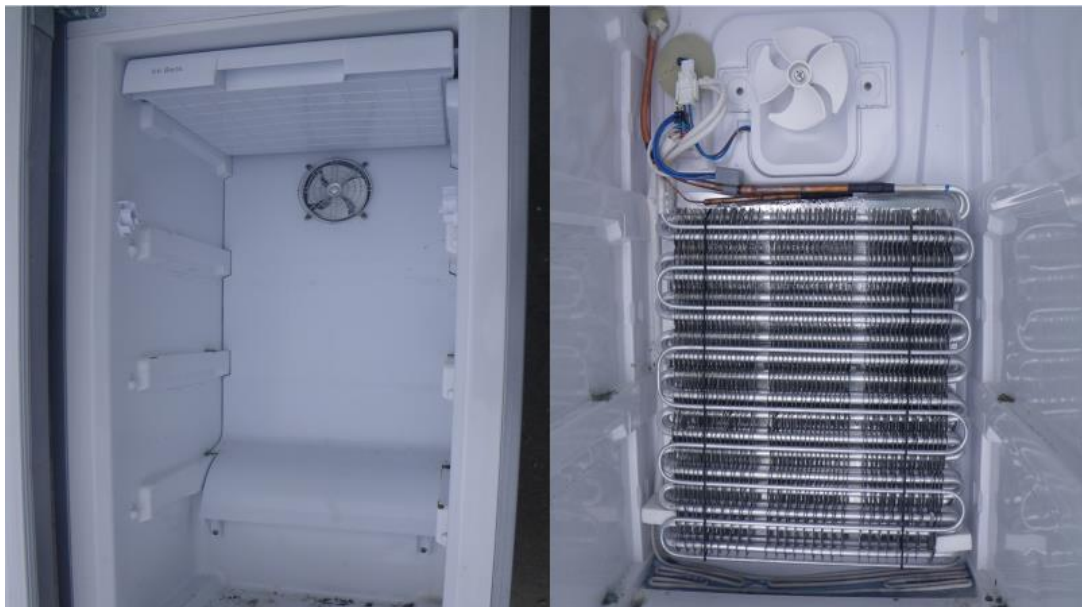
Figure 3.2. Freezer section of a modern Fridge/freezer (a) has internal cover removed (b) to expose the evaporator and fan assembly. The steel fan cover will also be an identification flag in the debris of a severe fire. (Amenity site 09/2017)

figure 3.2. Is located beneath a plastic (earlier metal) cover. Its surface is stamped with a manufacturer make and a date of production. The retailer states that the cost of this component together with storage limitations, prohibits long term stocking of the item, so normally the date found is within a couple of months of the production of the complete appliance. In a severe fire, the evaporator often survives due to its location, being insulated, and often in a freezing environment clearly slows the fire spread in this area. Photographing a large number of discarded appliances has become a valuable reference facility for identification of fire damaged products from incidents.

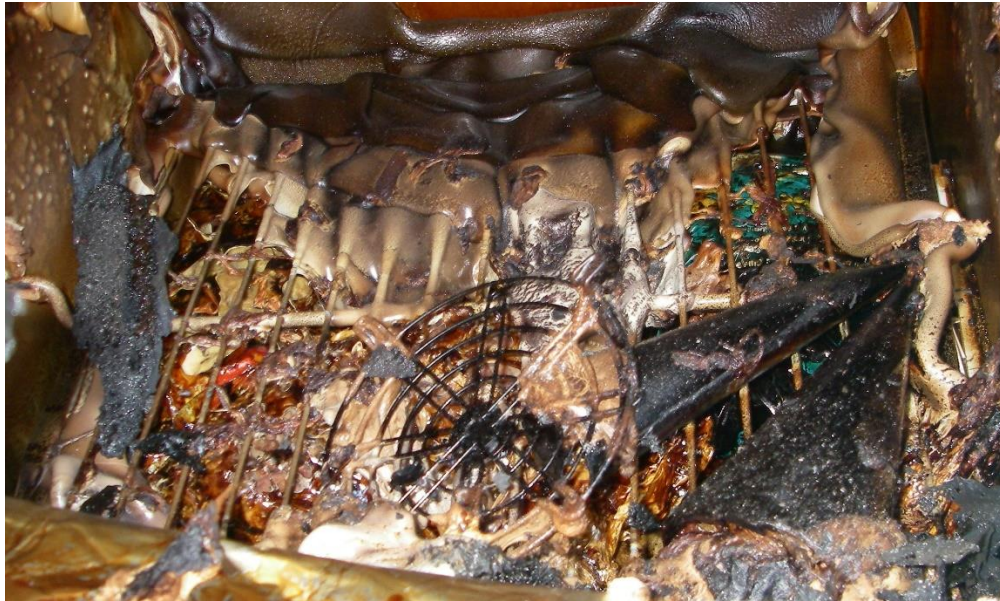
Figure 3.3. Steel fan cover in internal debris (LFB Fire incident 101005091 06/2009)

A severe fire which has spread to the interior of this appliance. Figure 3.3. Steel fan cover can be seen in centre of melted debris.

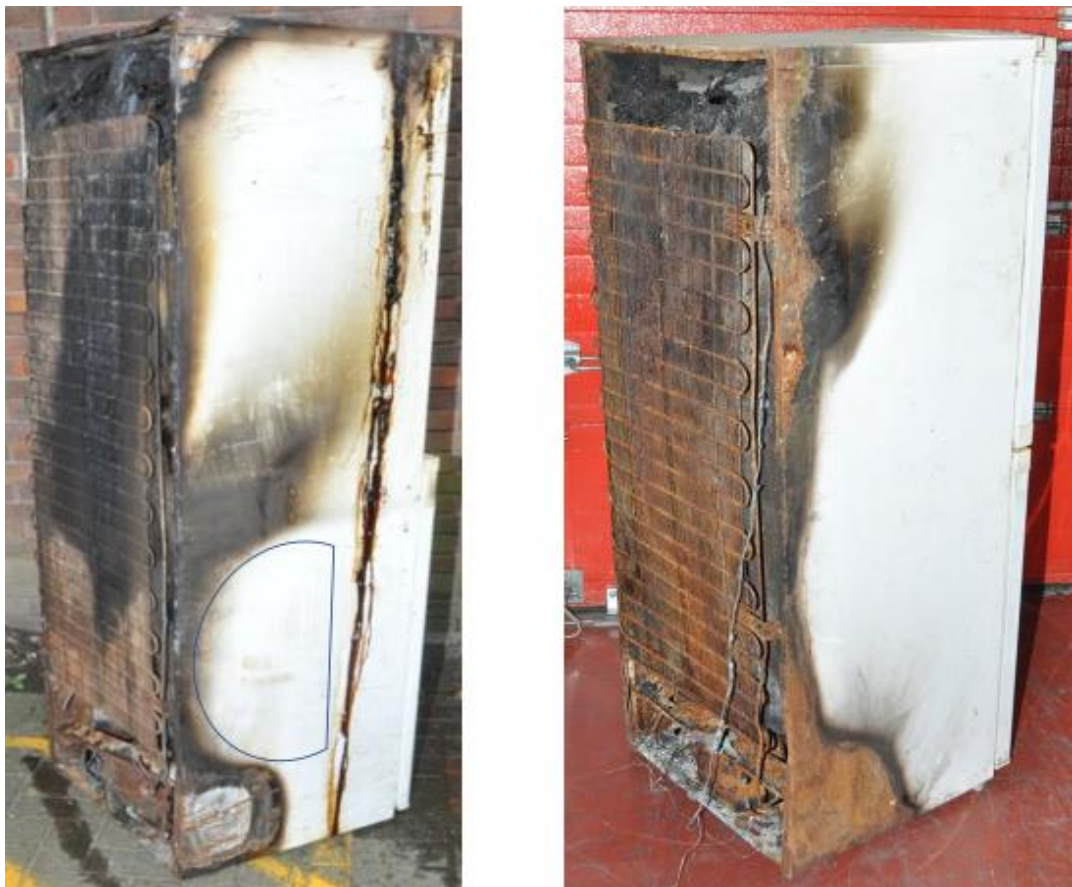
Figure 3.5. shows two different fridge/freezers ((a) Fire incident no 110421511 01/2015 (b) Fire incident no 57851131 05/2013) exhibiting similar burn patterns following a failure of a component within the rear compressor compartment. The circular burn pattern close to the floor results from a combination of direct flame impingement, radiant and convective heat transfer and conduction (Superposition). The white circular pattern of unburnt panel directly above is formed due to the cooling effect of the freezer compartment restricting the rate of burning into the appliance. The pattern is common when the fire has developed or reached the compressor compartment and is caused by a variety of initial failure modes.

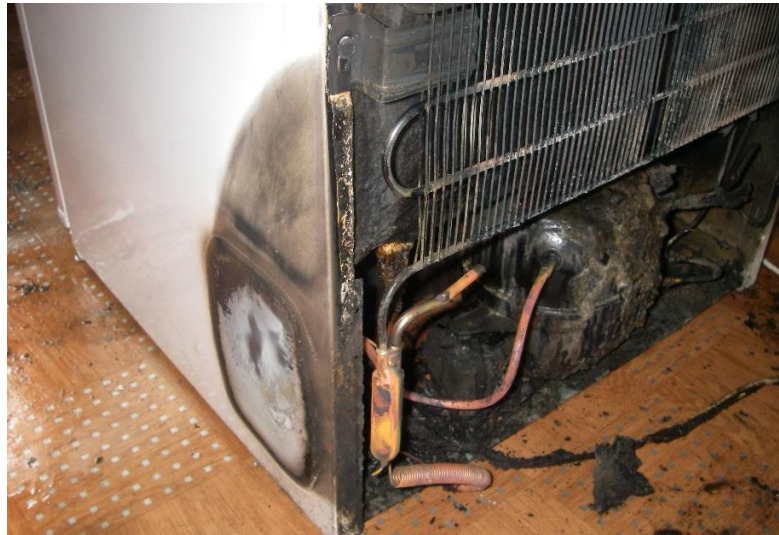
Another example, figure 3.6. with similar burn pattern but a less intense fire. This fire was caused by the failure of the run capacitor.

Figure 3.6. Further example of familiar burn pattern. (LFB Fire incident no 77514081 05/2008)

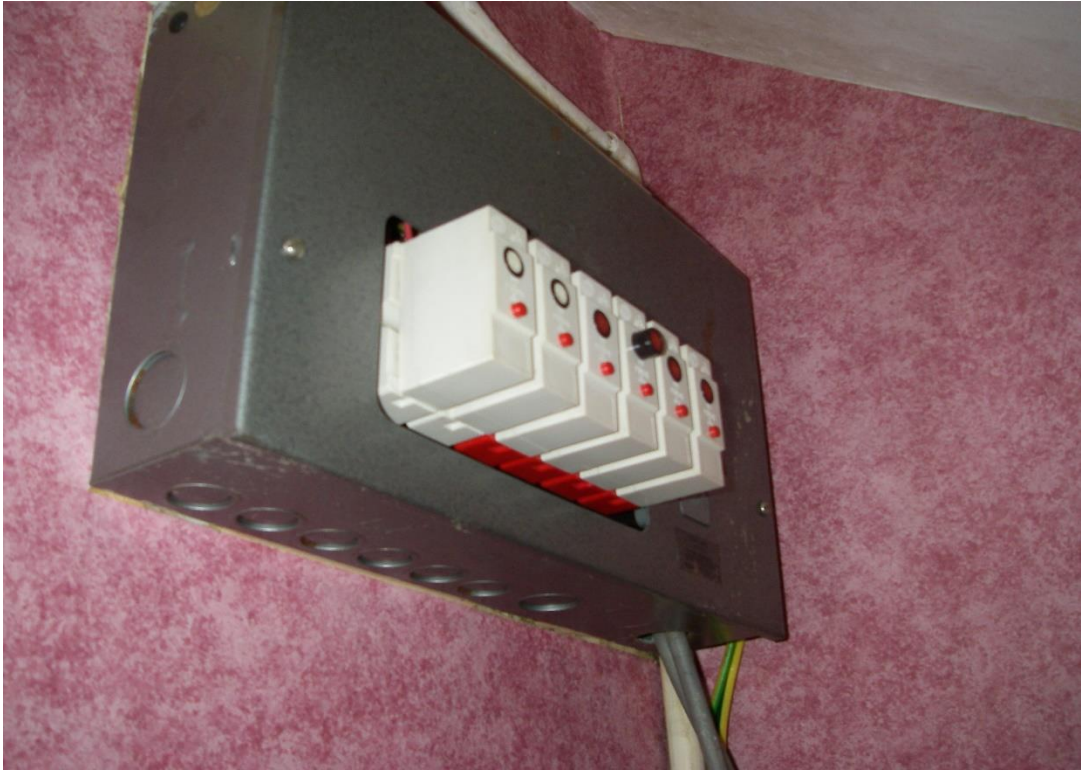
The consumer unit indicated that the circuit protecting the socket outlets to the room had either tripped or was previously operated. (Figure 3.9.). There were unlit candles placed on an adjacent table. No evidence of smoking materials was found

Figure 3.9. Electrical consumer unit showing one circuit breaker operated.

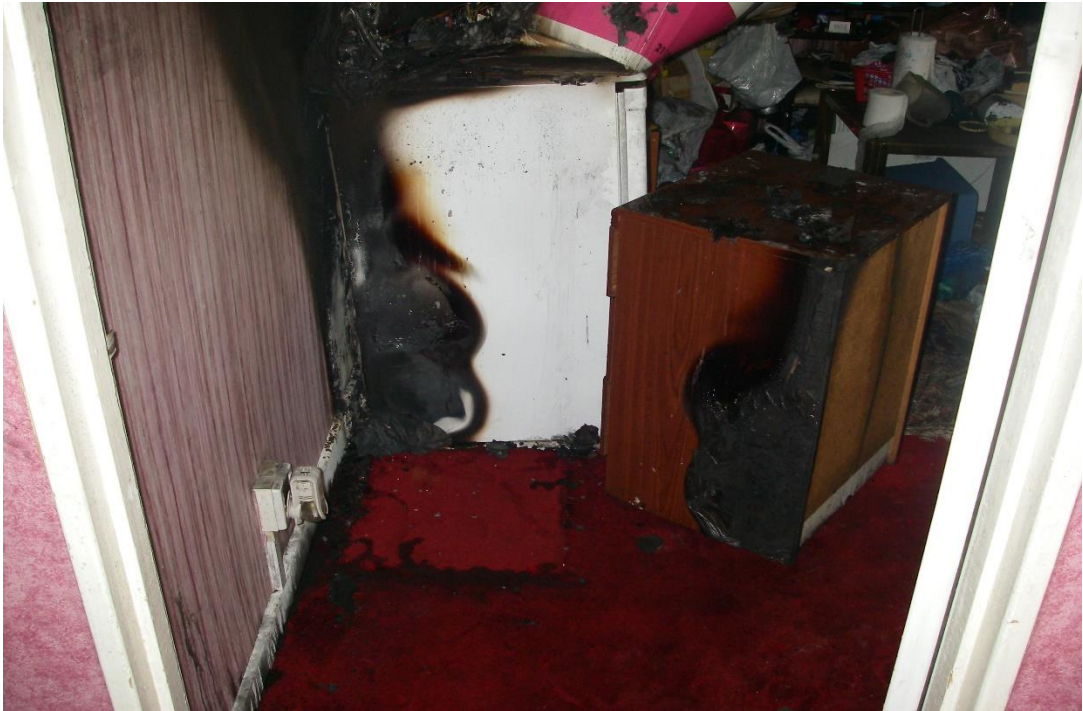
A small bedside cabinet was located next to the refrigerator (left side). The cabinet was moved to reveal a burn pattern matching that found on the side of the refrigerator (Figure 3.10) When the refrigerator was moved, a level of burning was observed to the rear. (Figure 3.11.) Burning to base of the refrigerator was also observed along with a burn pattern to the adjacent wall surface.

Figure 3.10. The burn patterns observed on the refrigerator and the surrounding objects and surfaces including the adjoining cabinet.

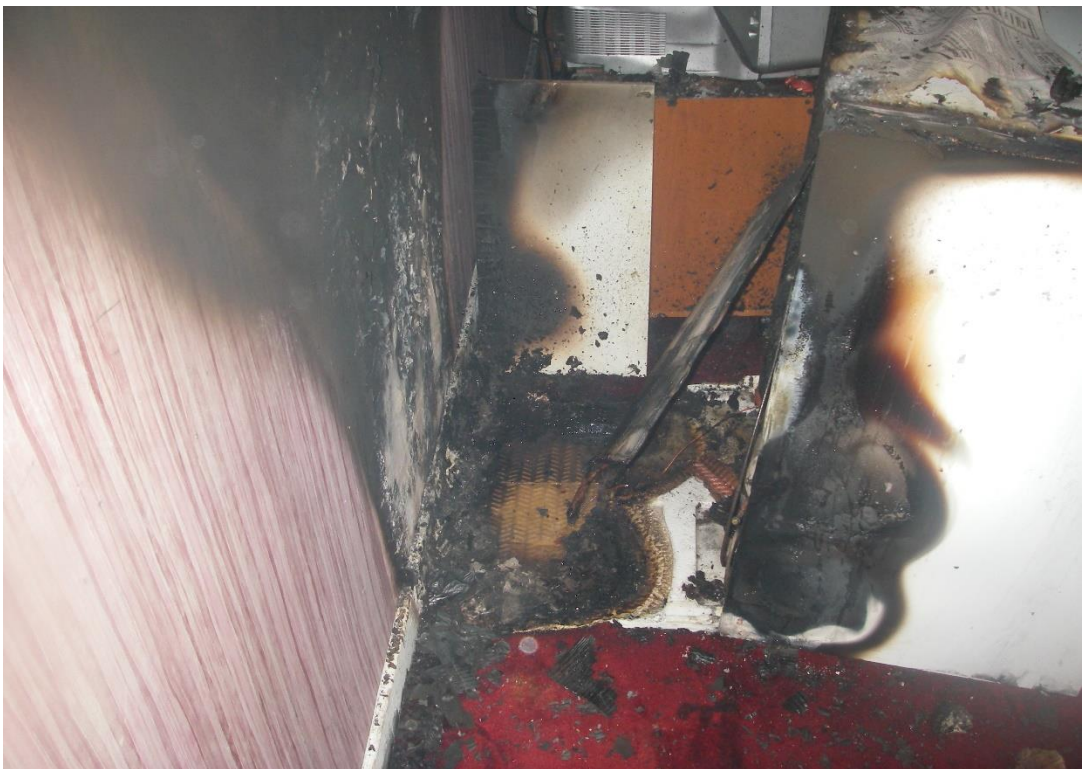
Figure 3.11. The refrigerator has been moved forward to reveal the damage to rear wall surface and floor beneath.

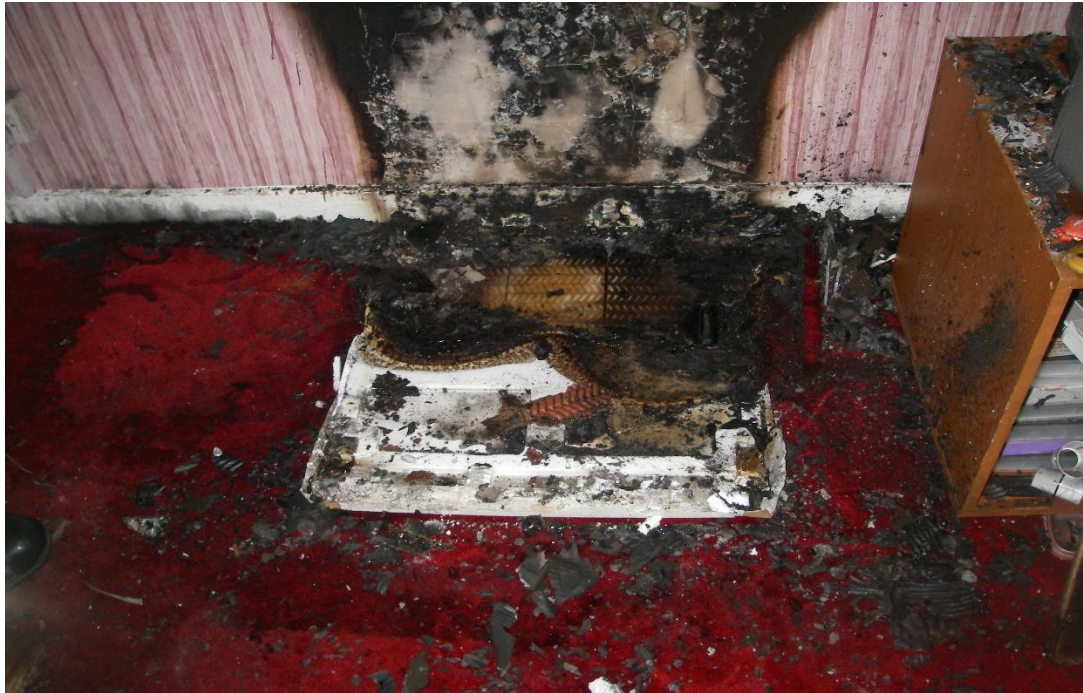
Figure 3.12. With the refrigerator removed, the remains of a base polystyrene and cardboard packing tray is observed. Packing materials are commonly found left in situ by owners', often years after installation.

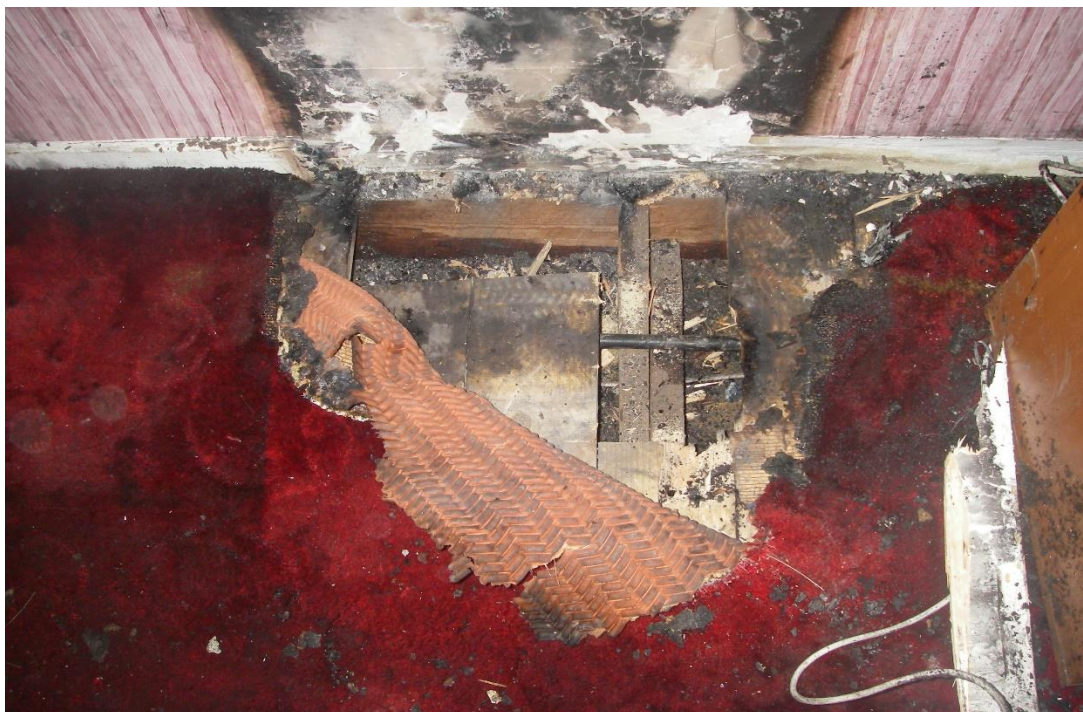
Figure 3.13. The floor beneath the refrigerator has been removed to check for any fire spread and confirms that the fire originated above the floor surface.

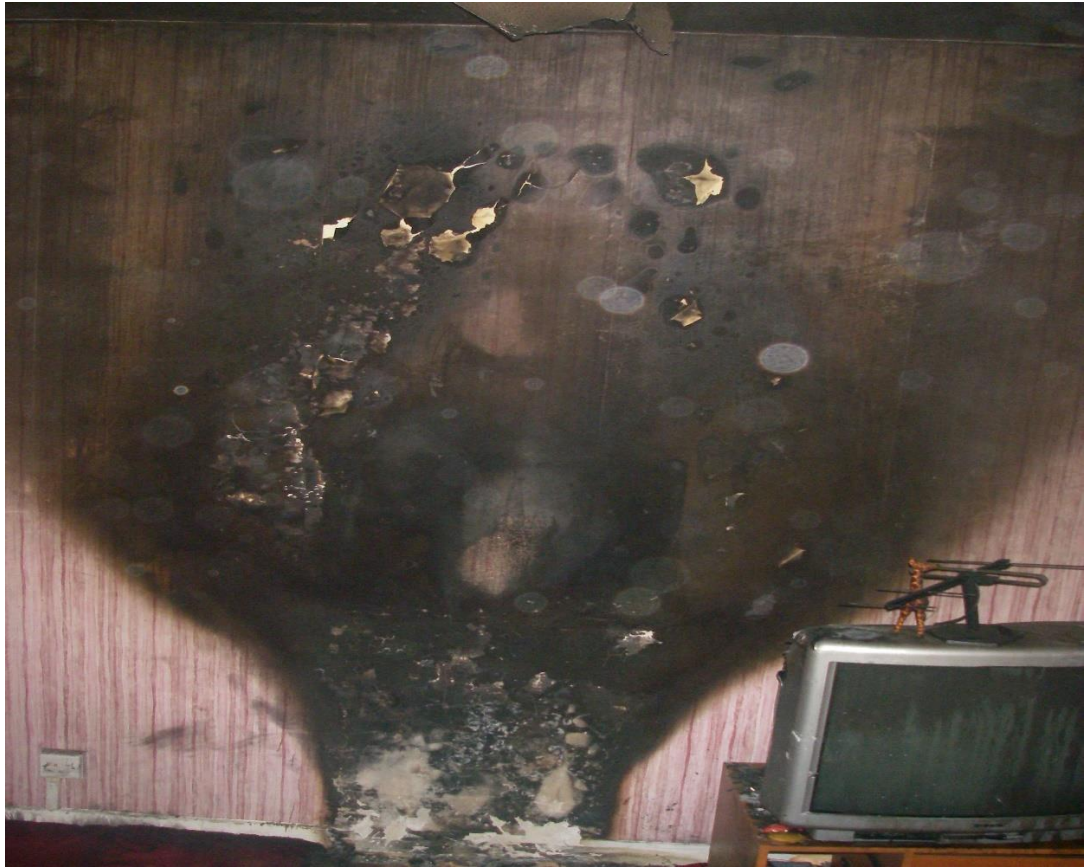
Figure 3.14. Pattern of burning to wall surface behind refrigerator

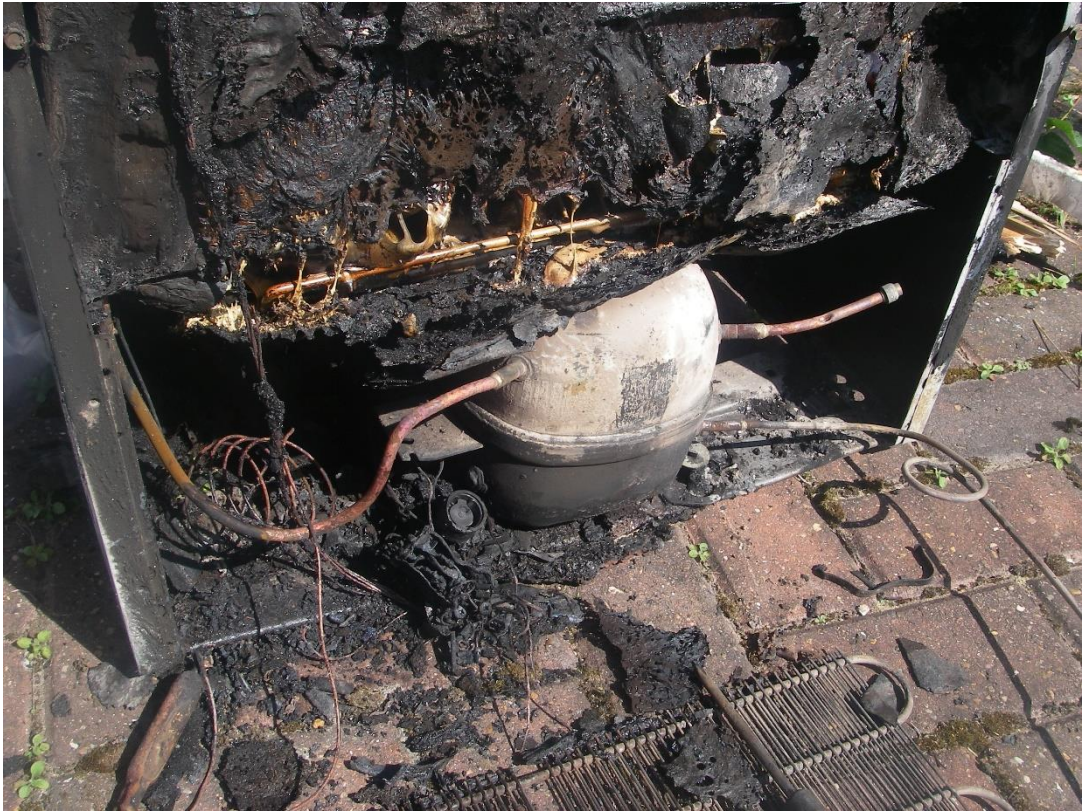
Figure 3.16. Rear of appliance showing low level fire damage and spread through compressor compartment

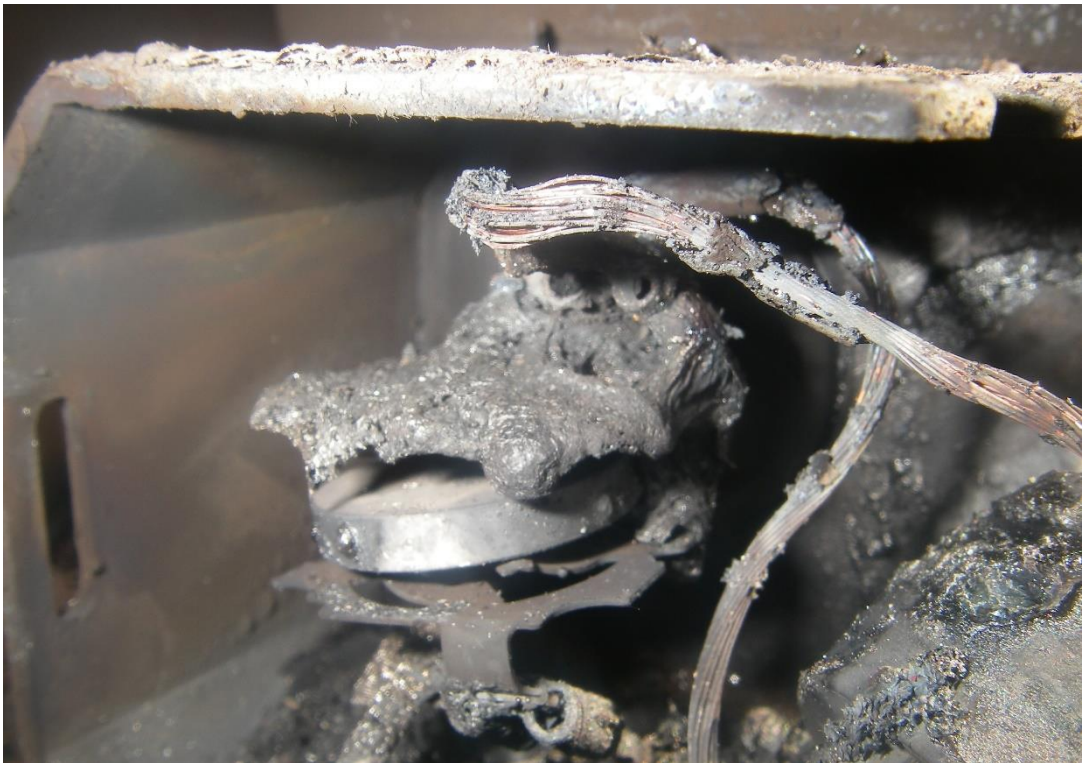
Figure 3.17. Close up of compressor positive temperature coefficient (ptc) switch showing side wall of pill

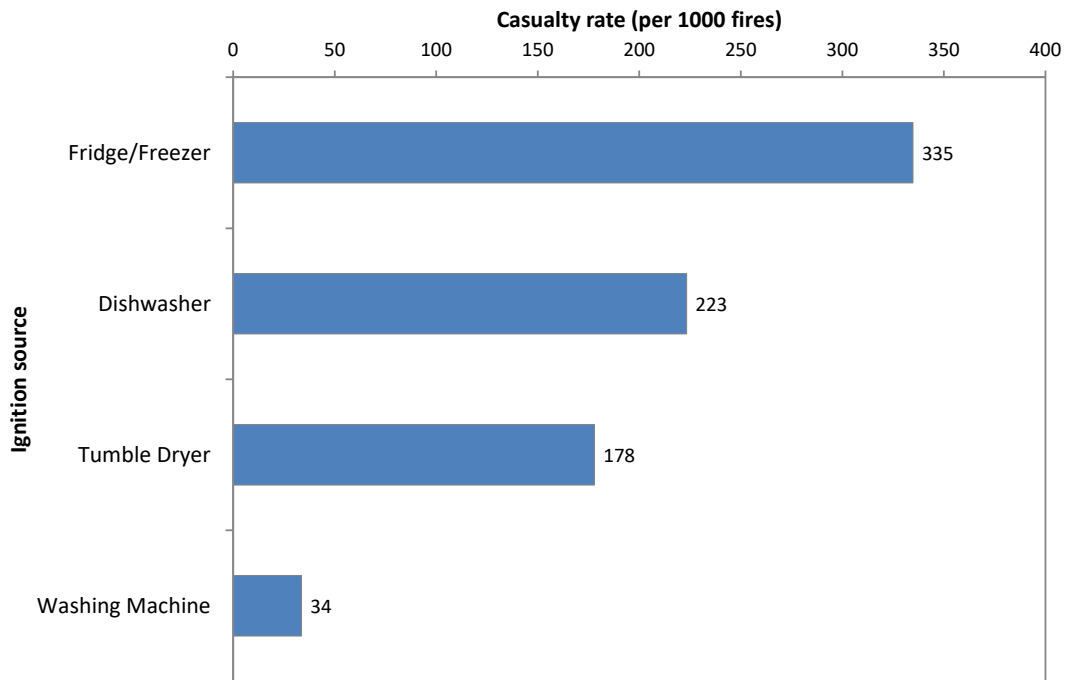
Figure 4.1. The different types of appliance ranked in terms of casualty rate per 1000 fires.

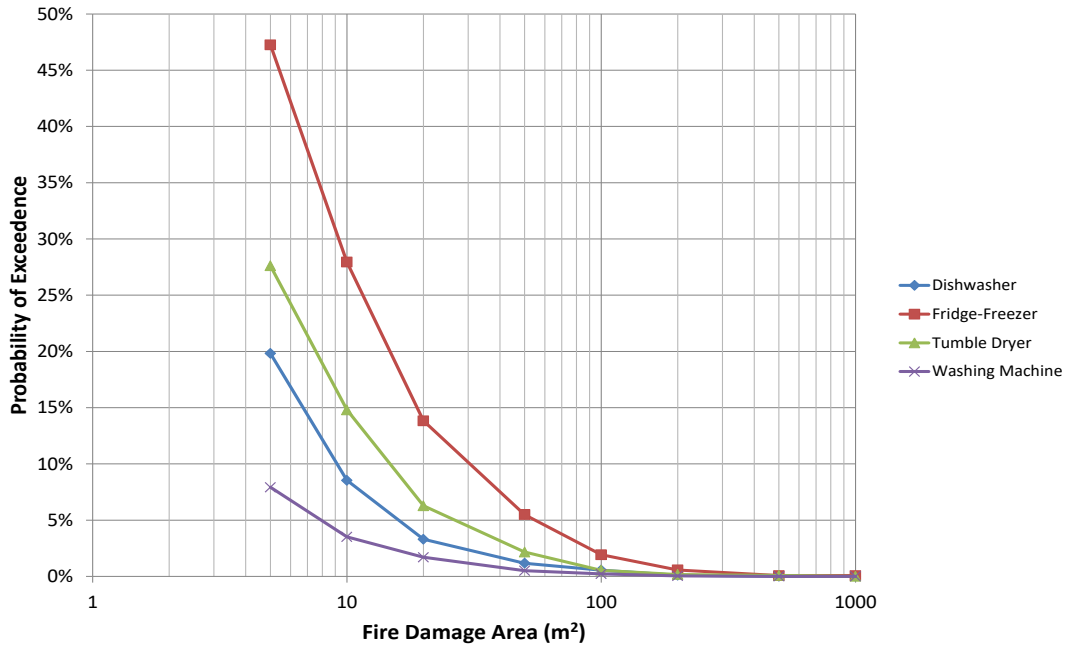
Figure 4.5. The CCDF for fire damage area, exhibited by different type of white goods appliance, for residential dwelling fires in England (DS-2). Each distribution gives the probability of fire damage exceeding a given area.

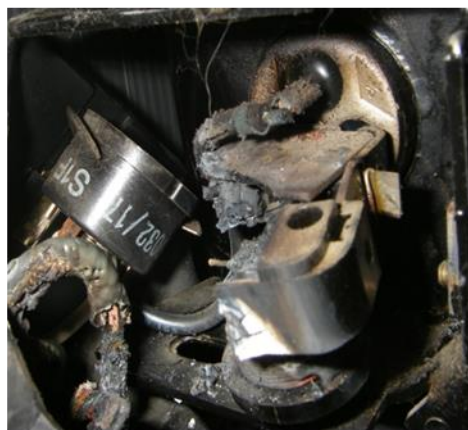
Figure 5.1 (a) An undamaged starter relay(Amenity site visit 10/2005 Ref no 6) (b) an example of a typical starter relay failure – note the white pyrolyzed plastic region; (c) break-up of the pyrolyzed plastic region upon removal. (b) and (c) Ref LFB Fire incident 04/2007

Figure 5.1(b) shows an example of a typical starter relay failure, resulting in severe heating to the coil assembly and external heat damage to adjoining cabling. The centre area, seen with white pyrolyzed plastic, has broken up

following an attempt to remove it (Figure 5.1(c)). This particular failure produced a small amount of smoke and an ‘electrical burning’ smell.

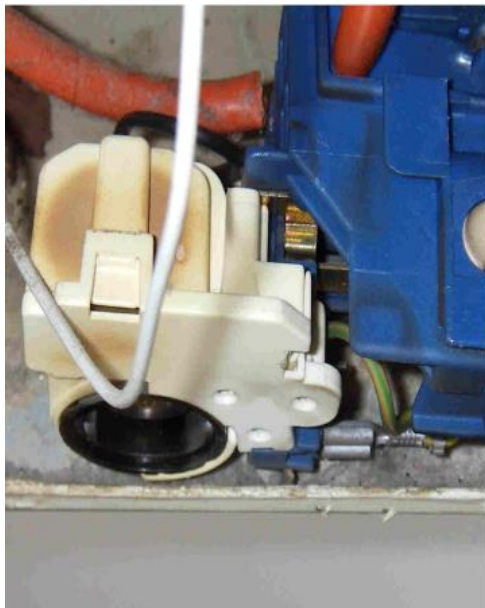
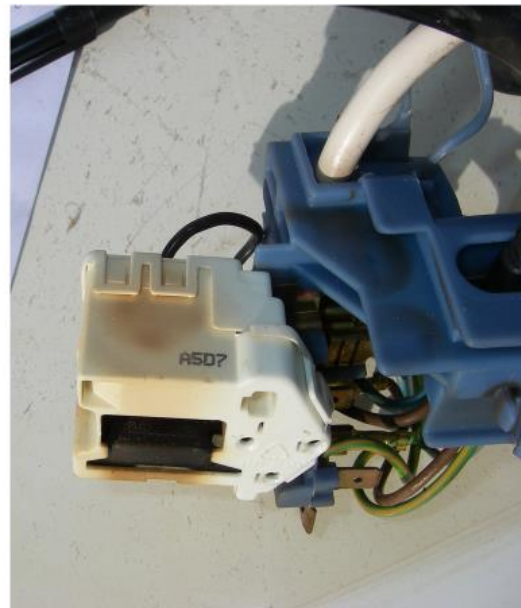
Figure 5.2 Examples of heat deformation to PTC switch casings

The switch continues to operate whilst the fire resistance of the plastic casing slowly degrades. (a) Amenity site 11/2006 Ref PTC no 61) (b) Amenity site 10/2006 Ref PTC no 322)

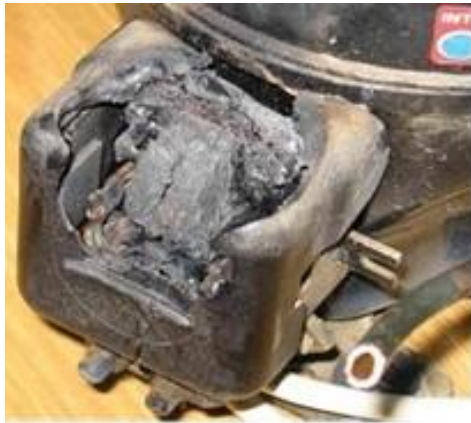
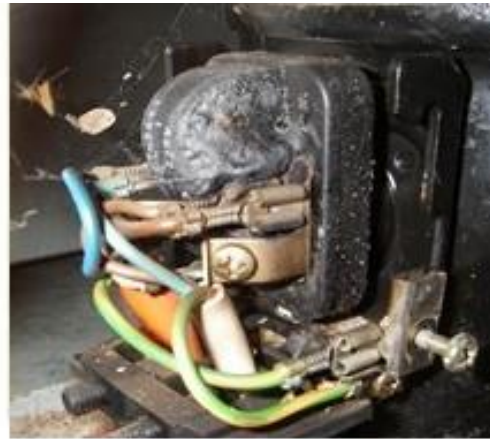
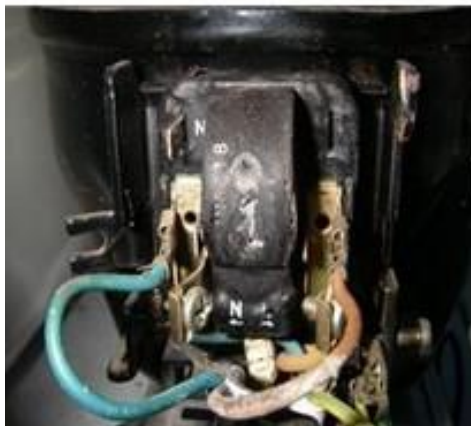
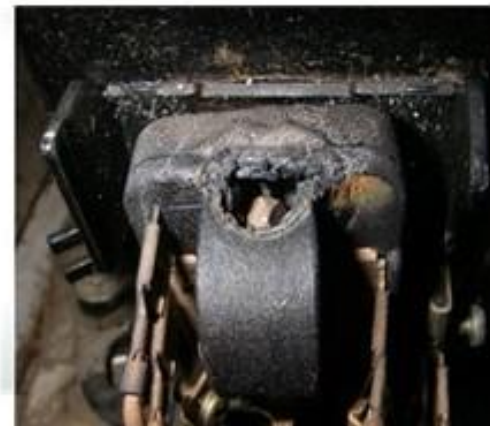
Figure 5.6 Examples of thermal decomposition in failed PTC switch's (a) Bureau Veritas sample. (b) LFB Fire incident no 84294101 05/2010. (c) LFB Fire incident no 143805131 02/2013. (d) Amenity site visit 11/2006 Ref PTC no 324.

Figure 5.6 shows a selection of Danfoss PTC starter switch's displaying differing levels of decomposition. The heat generated from the current passing through the PTC pill slowly bakes the plastic covering. Inside the switch, crystals of Adipic acid form, which provide a constant electrical path across the side of the ceramic PTC pill. The resulting heat begins a pyrolyzing process. The plastic covering of the PTC pill switch expands leaving the switch with a swollen casing, which typically cracks open. Figure 5.6(a) shows the outer cover, partially pyrolyzed and burnt, exposing the switch beneath. Figure 5.6(b) shows a severely swollen ptc cover, a common stage in the switch's degradation. Figure 5.6(c) shows another switch with a later compressor mounting cradle, but still utilising the same switch design. The pyrolysis process in this case is at an earlier stage. Finally, figure 5.6(d) shows a hole burnt in the case and pyrolyzing/burning through the switch plastic, (notice the char layer around the edge of the hole exposing a piece of PTC pill within. Although the pill had fractured, the switch was still functional and able to pass a start current to the compressor. This freezer appliance was kept at New Cross FIU and was filmed, with the starter switch still functioning.

The manufacturers later confirmed that the addition of nylon within the make-up of the covering had been changed and they were confident that no similar failure would occur in the modified switches.

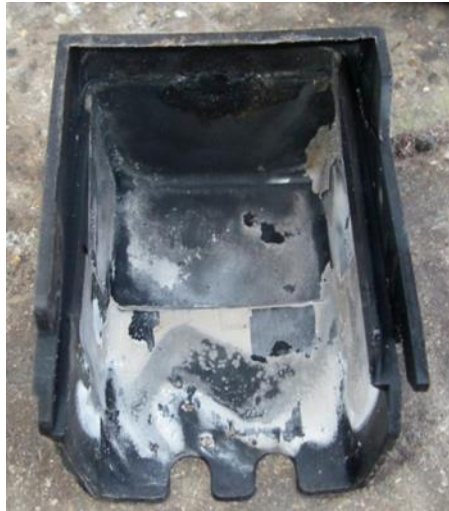
Figure 5.7 Build-up of adipic acid inside the cover of a PTC switch.

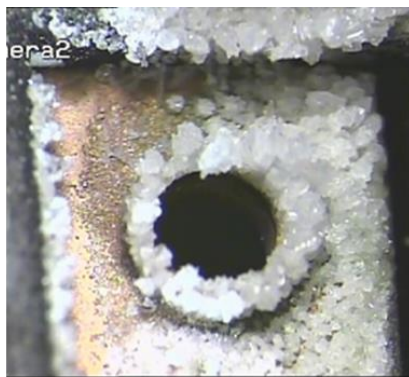
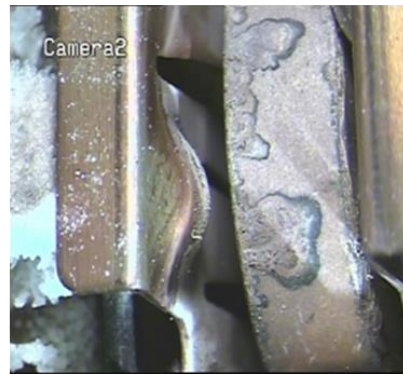
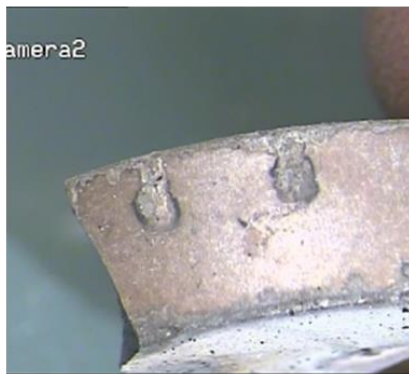
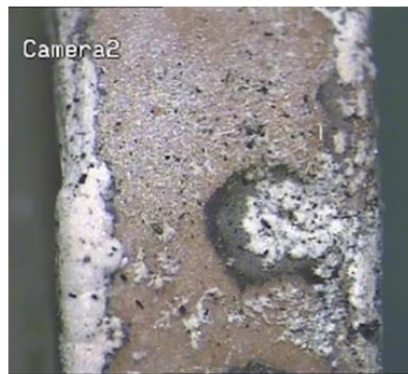
Figure 5.8 Some examples of adipic acid found on PTC switches.

The white crystalline material which develops on the surface of the switches is adipic acid produced by a reaction involving nylon present in the switch's casing material. A build-up of adipic acid was often found to be present inside the switch cover prior to or following the failure of the switch (Figure 5.7).

Figure 5.8(a-b) shows example of adipic acid found on switch surfaces viewed under a microscope. The acid also appears to damage the ceramic edge (see Figure 5.8(c-d)) creating a potential arc path across the pill.

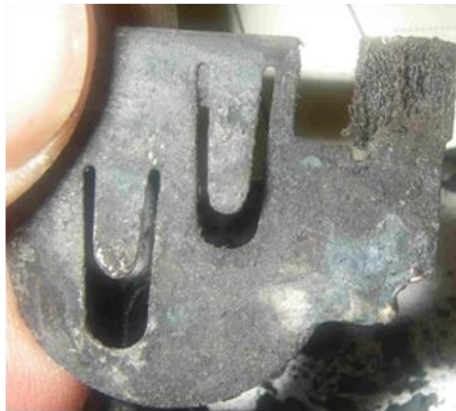
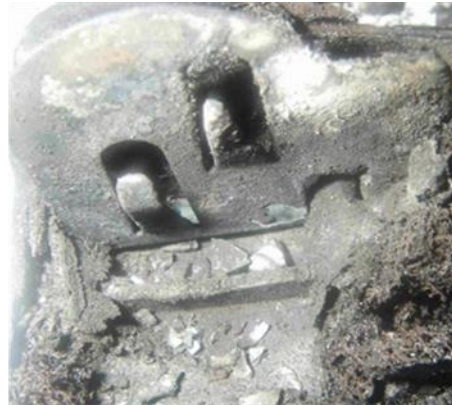
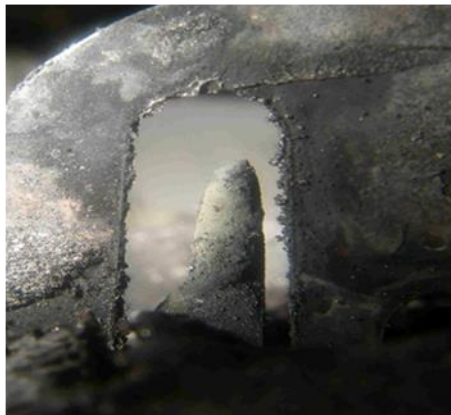
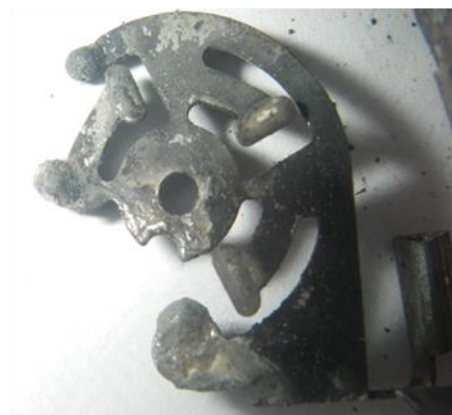
Figure 5.9(a) shows a side contact plate which is normally a light brass colour. Heat from the contact with the PTC pill produces the almost white coloured circle. Figure 5.9(b) shows the result of arcing from the PTC pill to the sprung metal contacts, resulting in distortion and melting of the metal plate. These switch plates will survive the severest domestic house fire, providing evidence of long-term arcing and failure of the switch. Figure 5.10 shows

some further examples of PTC switch contact electrical damage to the sprung contact arms.

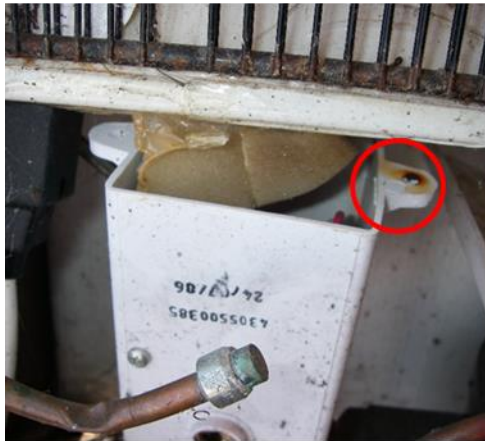
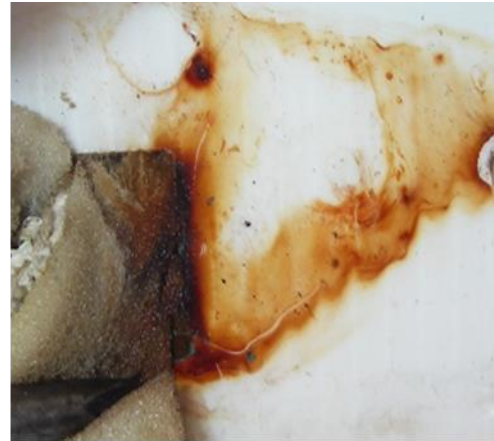
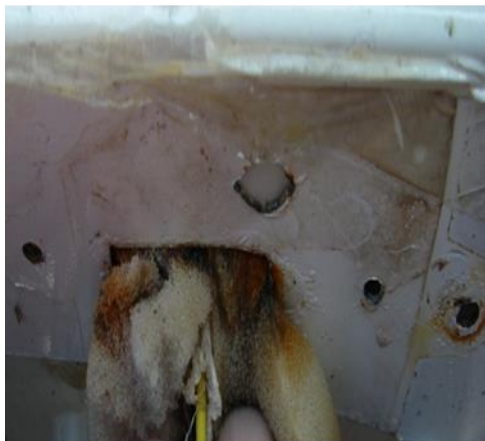
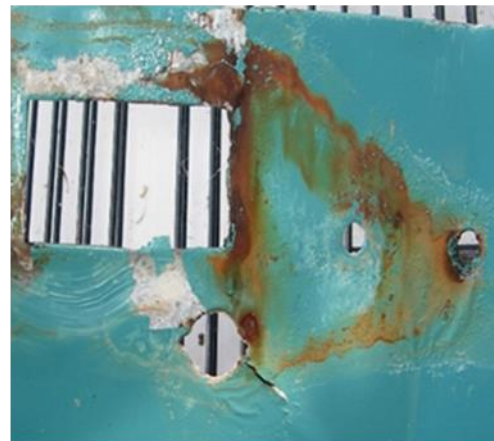
Figure 5.12 (a) Evidence of rust deposits around the screw holes; (b) foam pushed into the defrost switch wiring hole; (c) water staining to the foam matching the metal covering plate indicating that water entered the switch from above; (d) further evidence of water/rust staining around the hole.

Upon removal of the defrost cover from its mounting, rust deposits were observed around the screw holes (Figure 5.11(a)). A piece of foam had been inserted into the hole through which the defrost wiring enters the fridge above (Figure 5.11(b)). Water staining to this foam, matching the metal covering

plate, indicated that water had entered the switch from above (Figure 5.11(c)). There was also evidence of water staining/rust around the hole. (Figure 5.11(d)).

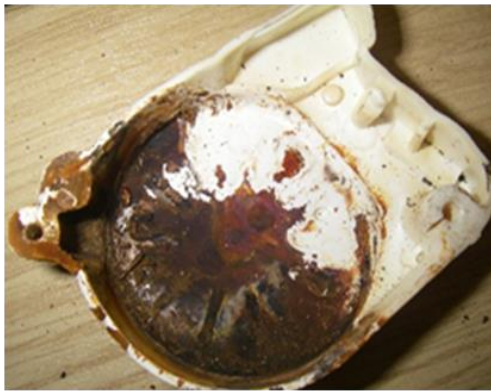
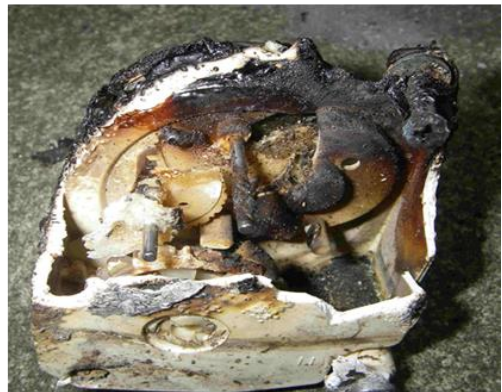
Figure 5.14 Dismantled defrost timer: switch's (a) the undamaged switch; (b-d) the heat damaged switch, revealing evidence of melting of the plastic casing and water ingress within the switch and timer.

The switch was then dismantled and compared with the undamaged switch (Figure 5.14(a)) to reveal melting and distortion of the plastic casing by the effect of heating and evidence of water penetration into the switch (Figure 5.14(b-d)). There was also evidence that severe arcing had occurred to the switch contacts (Figure 5.15).
