Causes, Consequences and Prevention of Fires in Domestic Refrigeration Systems

**A thesis submitted in partial fulfilment of
the requirements of London South Bank
University for the degree of Doctor of
Philosophy**

**This research programme was
carried out in collaboration with
the London Fire Brigade**

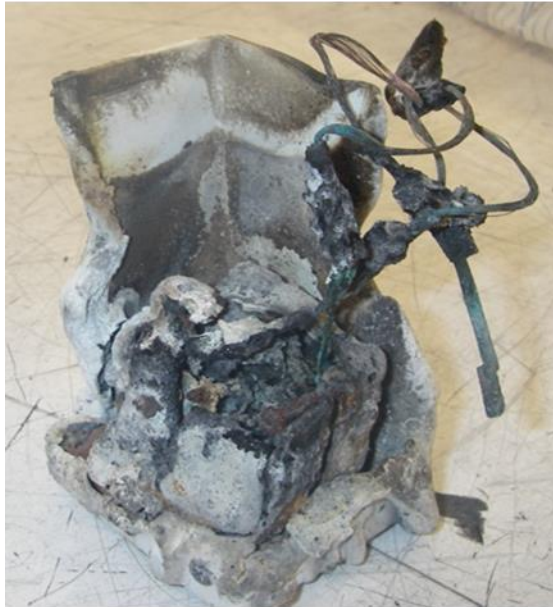
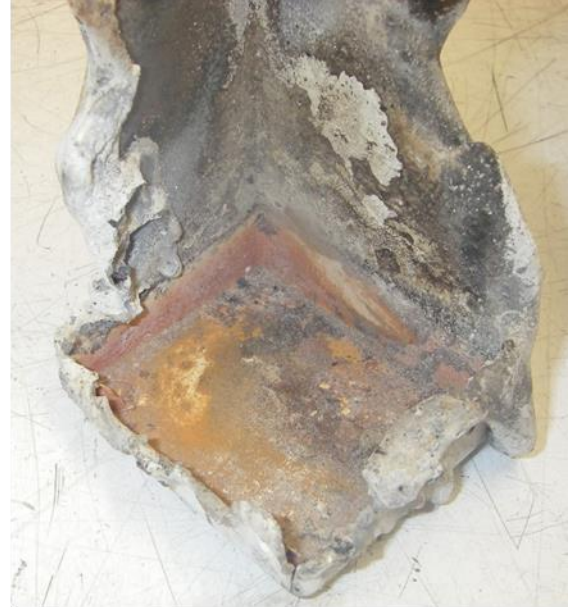
Figure 5.17 (a) An example of a rare case where a fire in a defrost switch was discovered and extinguished before the switch was destroyed; (b) evidence of water staining under the base of the switch cover. (LFB incident no 79992081 05/2008).

This process of ignition and burning of the defrost switch means that in almost all cases, the fire will spread rapidly to the insulation producing an intense fire (see Chapter 6). This process of destruction of the switch, and particularly its external casing, typically leaves little for the investigator to examine. Figure 5.17(a) shows a rare event where the fire was discovered quickly and extinguished before the fire could develop and spread to the insulation above. In this case, the switch was then removed to reveal water staining in the base of the switch cover (Figure 5.17(b)). Water ingress into the switch appears to provide an explanation for the cause of this failure.

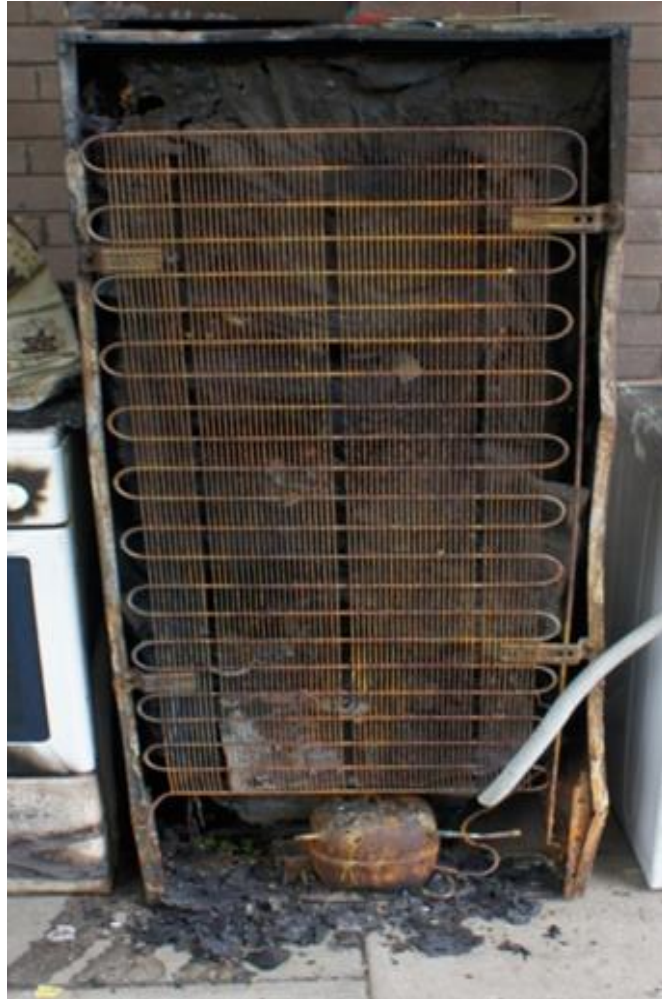
Figure 5.18 An example of a fire damaged appliance which was recorded as a defrost switch failure, illustrating the severity of the damage caused. (LFB Fire incident no 137039131 10/2013)

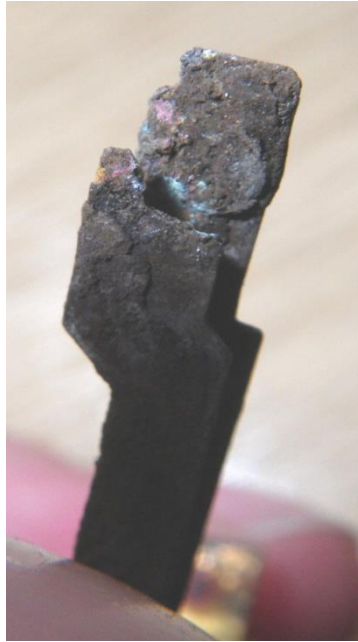
Figure 5.19 An example of the severe arc damage caused to switch contacts.

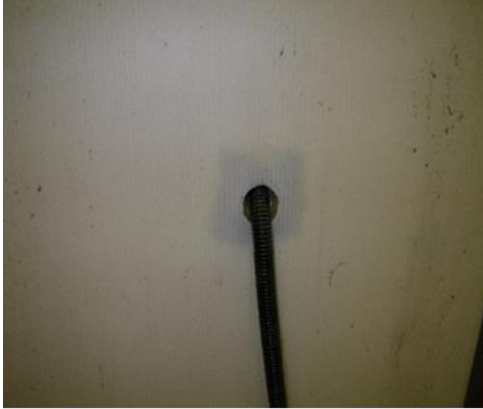
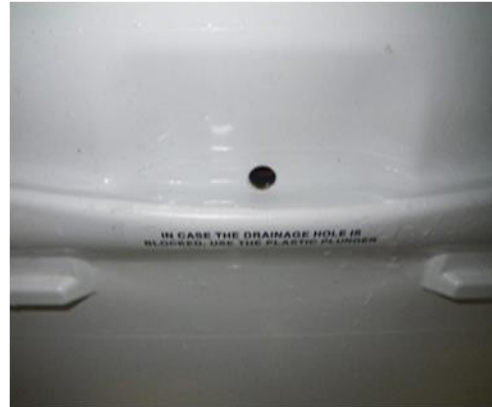
Figure 5.20 (a) and (b) **shows** drain pipe to rear of appliance and internal drain hole (b).

Figure 5.20 (a) illustrates the drain hole tube from the rear of the refrigerator section joins to the plastic outlet pipe. It is a push fit connection (Figure

5.20(a)). Although held in position by the rear condenser frame, (removed in photo) any disturbance to the drain hole, especially by attempting to poke something down the drain hole (as directed by some manufacturers - see Figure 5.20(b)) may well push the connection apart.

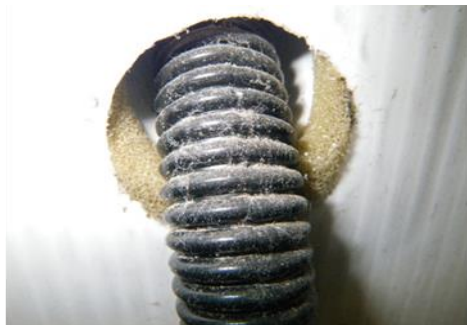
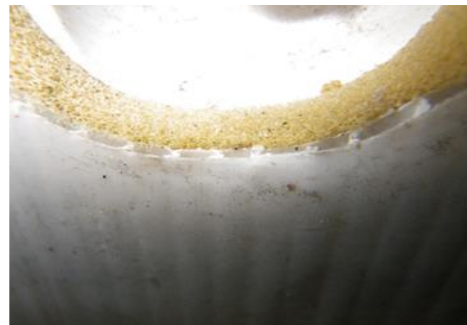
Figure 5.21 Plastic drain pipe (a). Twin-wall backing (b) foam insulation and drain hole.

Close up of hole in Figure 5.21 (a) and (b) shows construction of twin wall backing and foam insulating material behind it.

walled plastic fridge backing material, (Figure 5.21(b)) and pass down the backing, trapped between the two layers, where it could then flow into the defrost timer switch via the mounting screw holes.

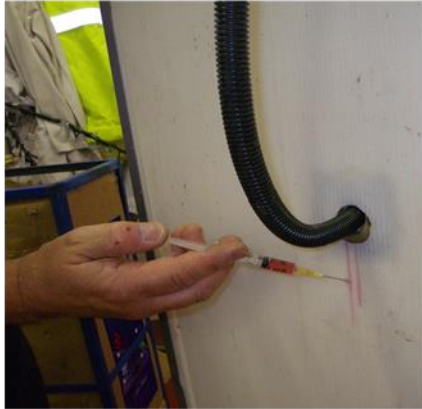
(a)

To test this theory, coloured liquid was injected into the cavity of the twin wall of a model that had the auto defrost switch factory fitted (Figure 5.22 (a)). The liquid ran down the tubes to the base. From here it was discovered that it could seep through penetrations in the sheet formed by the screws used to secure the main wiring harness and the defrost switch cover (Figure 5.22 (b)) and then run into the defrost switch by following the path of the wiring and flowing down to the connecting block. Figure 5.22 (c) shows the liquid has entered the plastic connecting block and started to heat up as a result of providing an electrical connection across the contact arms. This action also discoloured the base of the connecting copper contacts. Figure 5.22 (d) shows the liquid bubbling inside the plastic connecting block. This action did not result in a blown fuse or circuit failure. Hence it was concluded that this mechanism could explain how water was able to penetrate into the defrost timer switch.

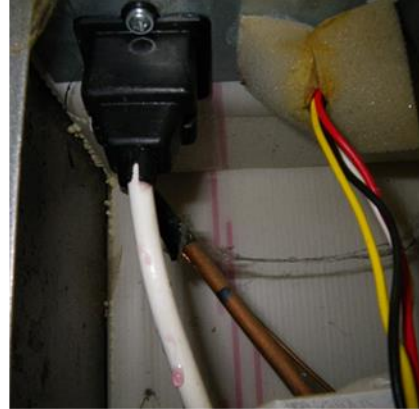
Figure 5.22 Testing the mechanism of water ingress into the defrost timer: (a) injection of coloured water into the fridge backing; (b) seeping through twin wall cavity following the wiring harness to the defrost timer; (c) water reaches the switch connecting block; (d) water forms a path across the switch contacts.

This type of defrost switch has been in use for many years and is fitted in many other appliances. The specific problem of this failure has not been reported by other manufacturers, although ingress of water may be deemed a problem in other circumstances. For example, PTC switches can also fail due to water ingress. Many appliance manufacturers have now switched to using electronic timers as was the case with this particular manufacturer.

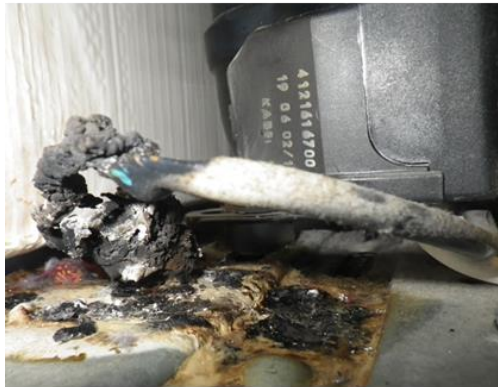
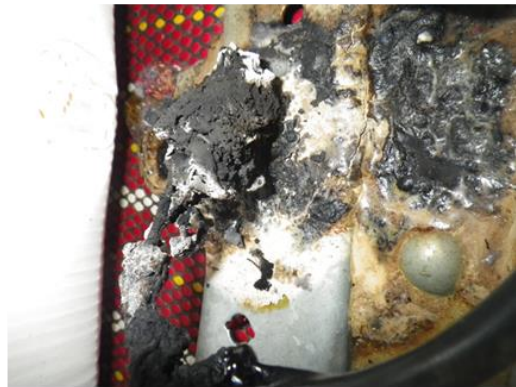
Figure 5.23(a) shows an example of a capacitor failure within the compressor compartment of a freezer, which was approximately 9 years old. (LFB Fire Incident no 155184111 03/2013). Such a failure resulting in only limited fire damage is rare. It would also seem likely that this type of (limited) failure may go unrecorded in some cases as there is a possibility that no call to the fire brigade would be made.

Figure 5.23 (a) (b) and (c). Capacitor failure resulted in limited damage to the appliance.

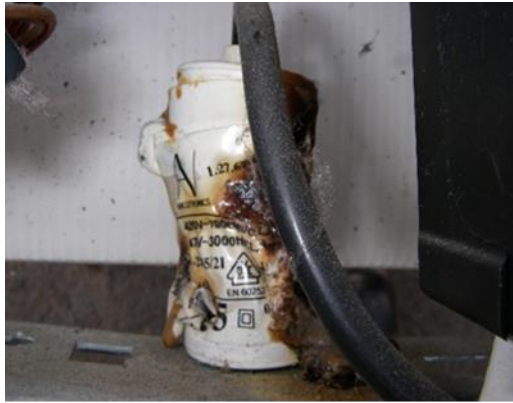
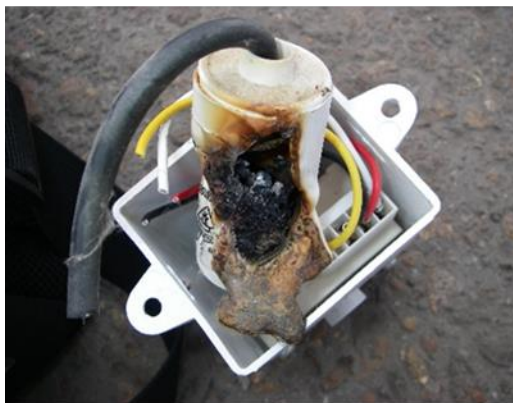
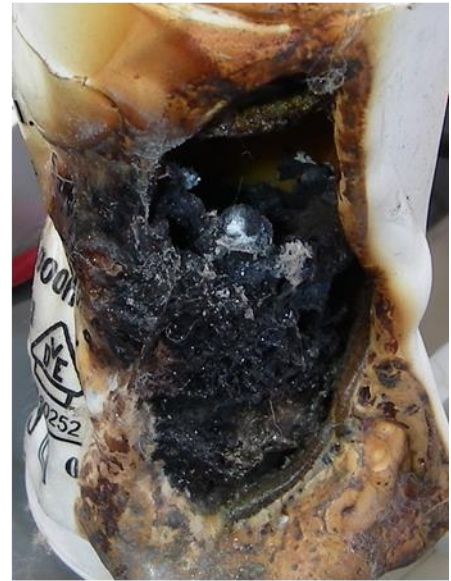
Another example of a capacitor failure in a fridge/freezer appliance resulting in only localised damage. Fig 5.24, (a), (b) and (c) (Amenity site visit **06/2009**) shows the capacitor prior to removal from the compressor housing, and the capacitor and defrost switch following removal from the appliance.

Figure 5.24 Capacitor failure in a fridge/freezer appliance resulting in only localised damage to capacitor. (Amenity site visit 06/2009) (a) shows the capacitor prior to removal from the compressor housing. (b) shows the capacitor and defrost switch following removal from the appliance. (c) shows a close up of the burning within the capacitor casing.

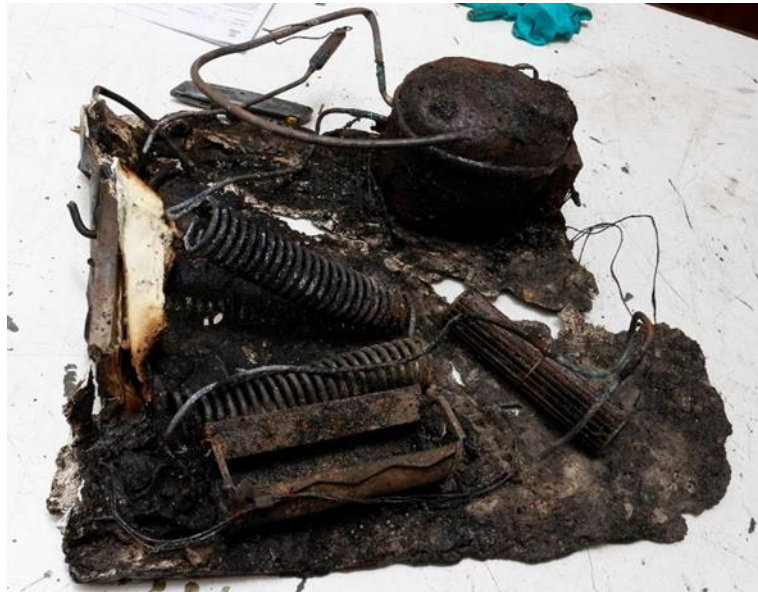
Figure 5.27 The remains from an integrated appliance fire.
(LFB Fire incident no 133116151 2015)

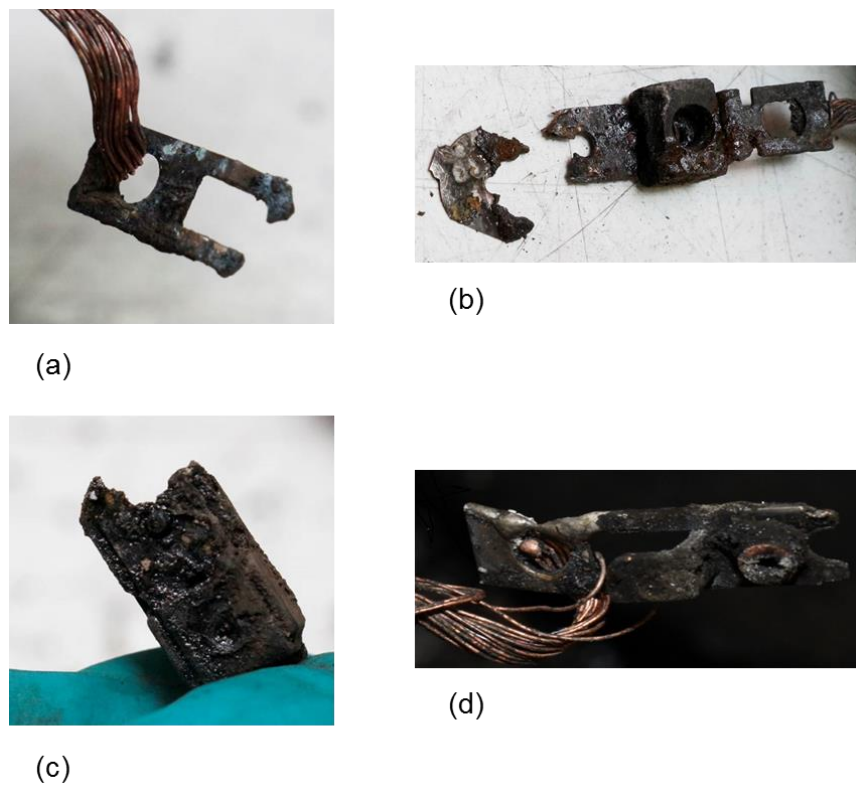
Figure 5.29 Examples of failed cut-out switches from integrated units that have been involved in fire incidents. (a) LFB Fire incident 133116151 10/2015

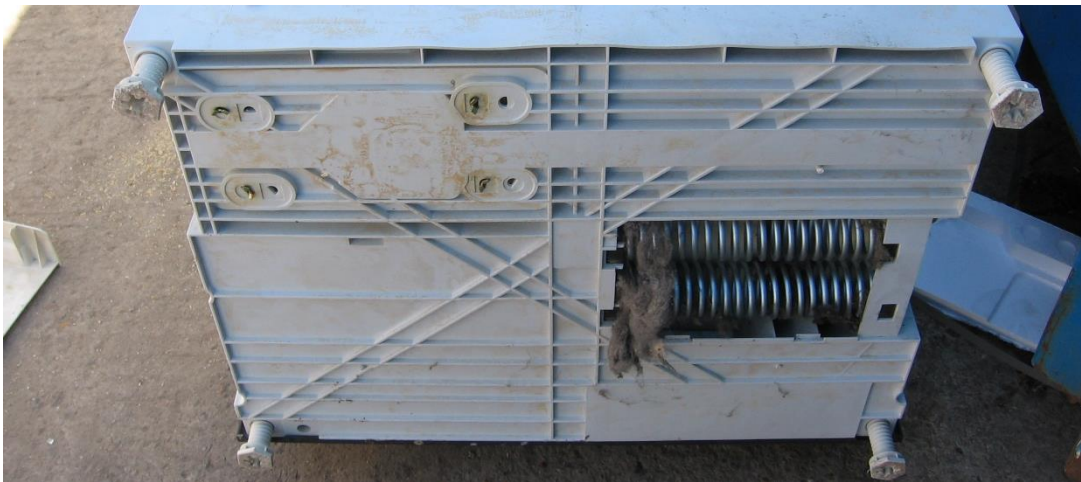
Figure 5.30 Underside of base crate showing distinct moulding pattern in plastic.

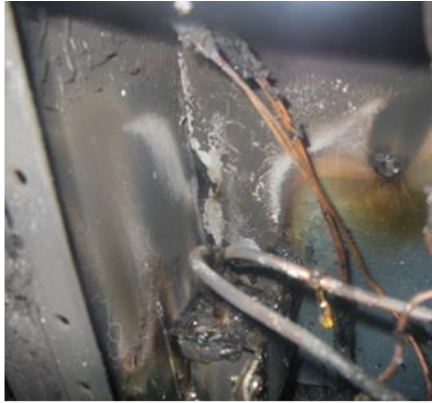
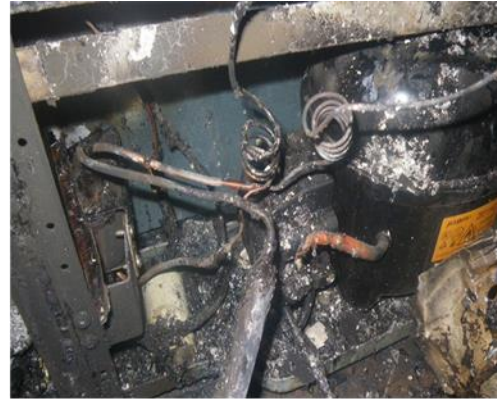
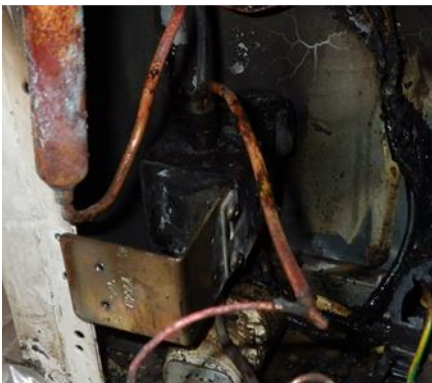
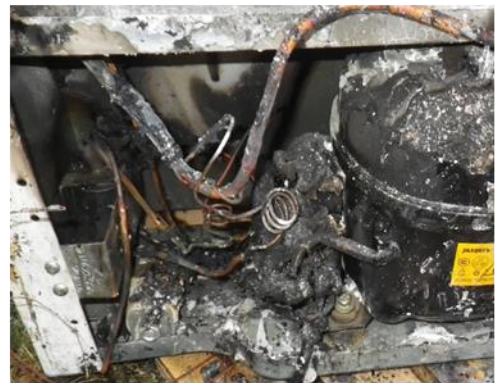
actual make of the failed solenoid used has been identical in each case involving different manufacturers. Figure 5.31 shows four separate examples of solenoid valve failures leading to ignition.

Figure 5.31 Some examples of solenoid valve failures leading to ignition.

These four examples of solenoid valve failures have resulted in ignition and damage to the compressor housing. The appliance wall behind the compressor is a metal plate. A burn pattern is left on the surface. The insulation directly above the compressor shelf is plastic and the developing fire can then spread quickly up the back of the appliance.

Following laboratory examination at Bureau Veritas, it appeared that the fire had been caused by the failure of the solenoid coil which had melted through the side wall of the solenoid valve barrel and allowed the refrigerant gas to escape, ignite, and spread the resultant fire to the surrounding materials.

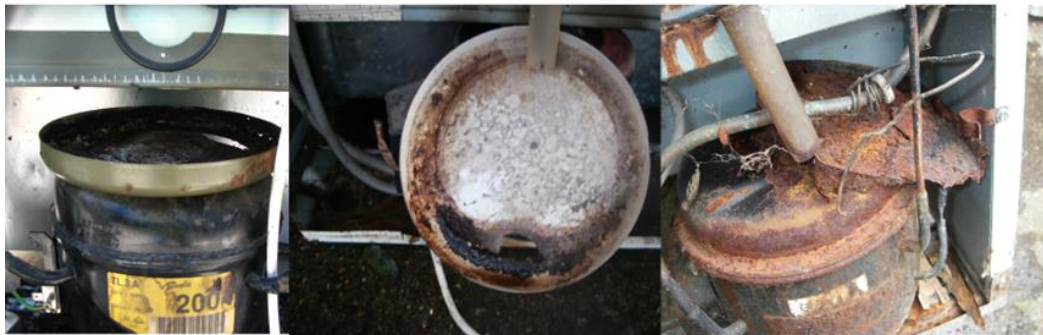
Figure 6.1 Some examples of corroded metal evaporation trays used in older domestic refrigeration appliances.

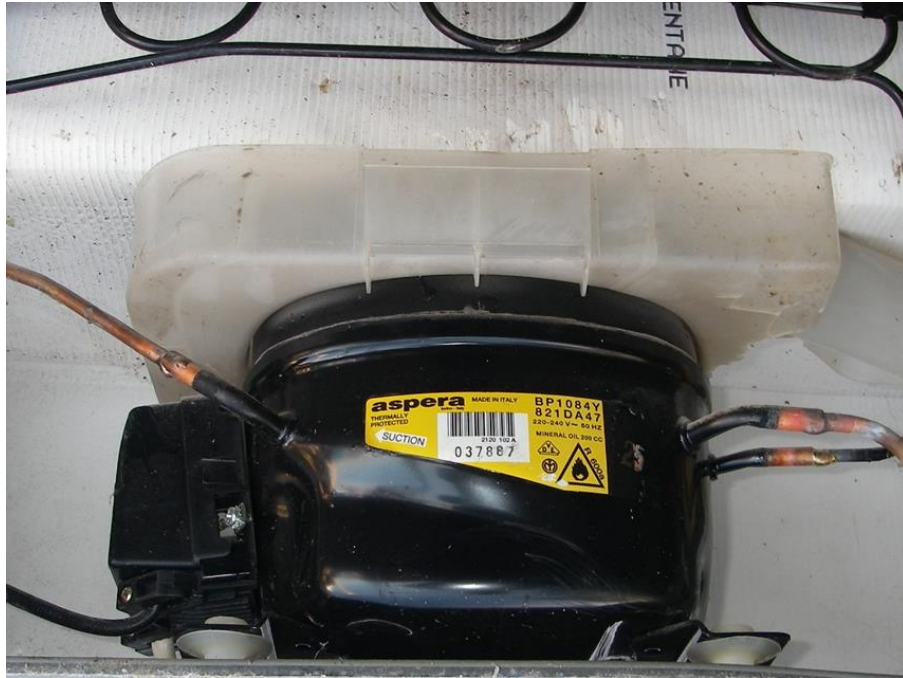
The manufacturer's response to this problem was to replace the trays with plastic variants. Figure 6.2 shows an example of an (undamaged) plastic tray.

Figure 6.2 An example of an undamaged plastic evaporation tray.

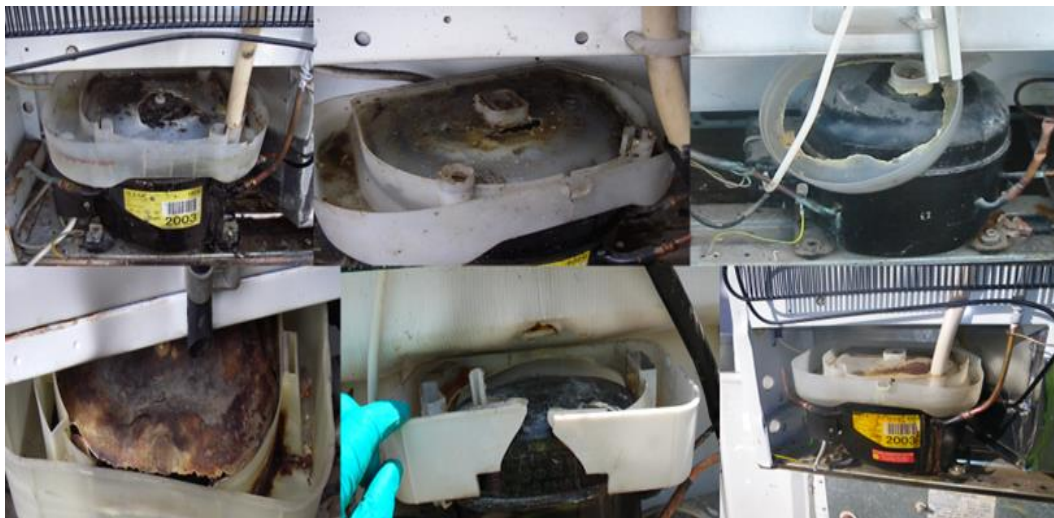
Figure 6.3 Six examples of plastic evaporation trays which have degraded allowing leakage. (Taken from research photos from amenity site visits)

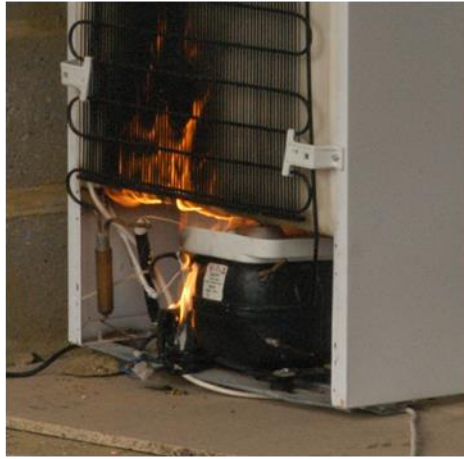
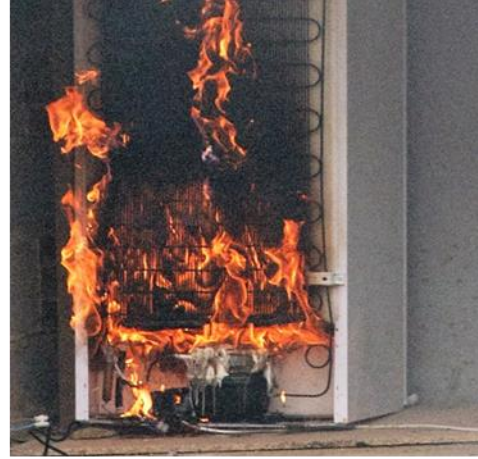
In the event of an ignition source starting a fire in the vicinity of a plastic evaporation tray, it can quickly become involved and help to spread the fire. To demonstrate this, in the test shown in Figure 6.5, a small flame has been introduced in the area next to the capacitor switch to replicate an electrical ignition of vapour, such as would occur should a PTC switch fail (see Chapter 5).

Figure 6.5 Fire test involving a plastic evaporation tray: (a) small flame in compressor housing; (b) the fire involves the plastic tray and spreads up the rear wall of the appliance. (LFB Refrigerator burn tests Wethersfield Essex Nov 2007)

From a small ignition source next to the PTC compressor switch, the flame rapidly spreads across the ceiling of the compressor housing before igniting the evaporator tray and spreading up the rear wall of the appliance. As the developing fire spreads vertically and also horizontally above the compressor, unburnt droplets and molten plastic from the evaporator tray, pool on the floor surface where they can be ignited by other flaming droplets and radiated heat from the fire.

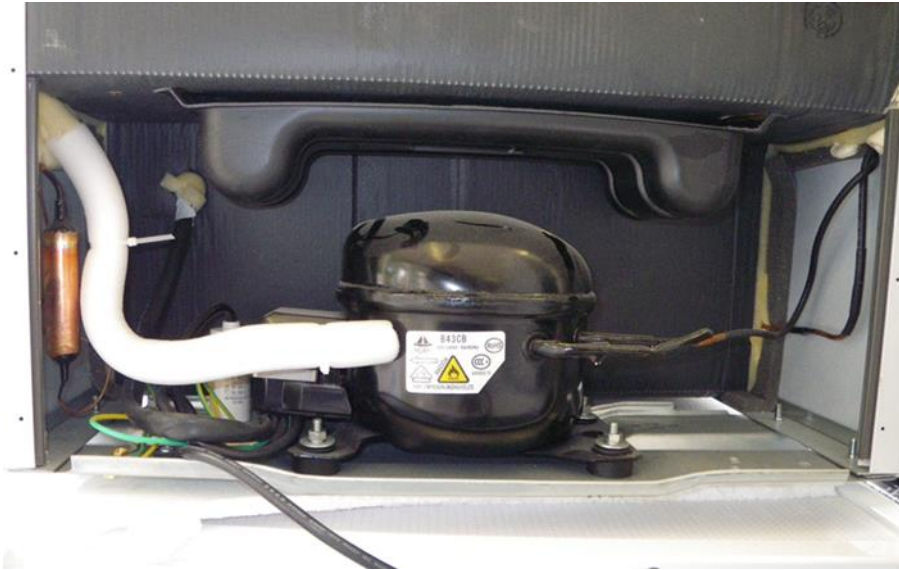
There are currently no regulations in the UK governing the size, shape or location of the evaporator container. A recent observed change (see figure 6.6) is for the tray to be raised above the compressor rather than be in direct contact. The size of the tray appears to have grown in area, but is shallower - perhaps to provide a greater surface area for evaporation. Whilst the raising of the tray may mitigate the problem of heat degradation, it is perhaps questionable how well the evaporation from the tray now works. Newer compressors on the market often generate less heat.

Figure 6.6 An example of a raised plastic tray in a modern appliance.

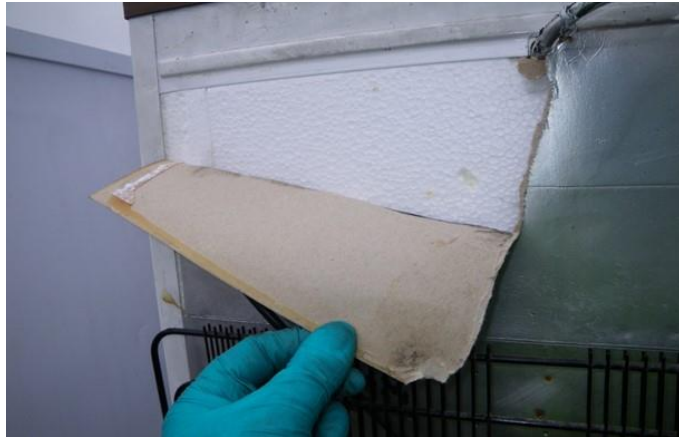
The metal panels used in older fridge/freezer designs as part of the frame, covered the insulating materials within forming an almost impenetrable fire barrier. This construction method has slowly been replaced in many appliance designs. There seems to have been an interim period in the construction of modern appliances from the 1980's to the late 1990's when either metal foil or foil backed cardboard was used as a rear wall covering of the insulating foam (see Figure 6.7). This material was used to provide a barrier against moisture ingress.

Figure 6.7 An example of metallised cardboard covering the rear wall foam insulation of an appliance.

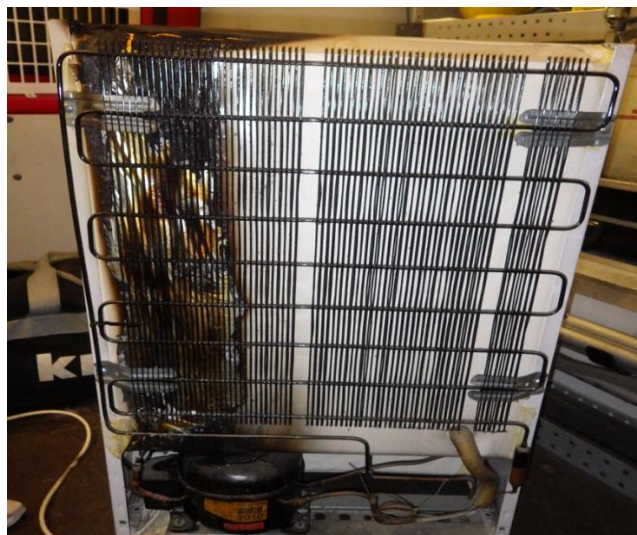
Figure 6.8 An example of flame spread up the rear of a pre-1993 appliance, backed by a plastic film covering metal foil, which has prevented ignition of the foam insulation material. (LFB Fire incident no 10885122 06/2012)

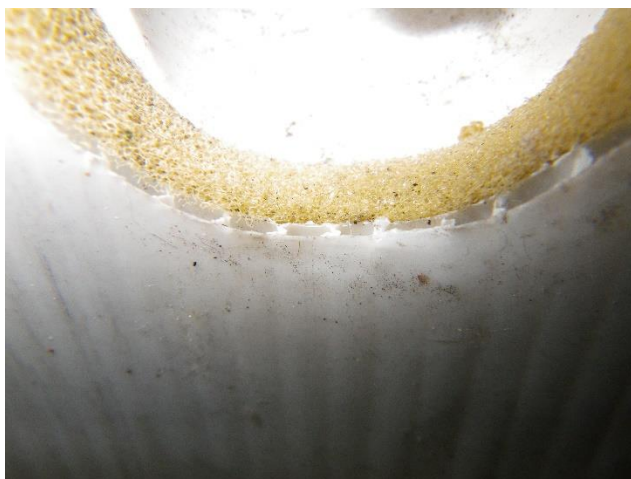
From the late 1990's a plastic - polyethylene/polypropylene back panel material known as a "twin-wall" began to be used (Figure 6.9). "Twin-wall" plastics are also often present as lining materials in the compressor compartment.

Figure 6.9 The twin-wall back panel cut to provide an outlet for water to drain through the rear wall of the appliance. The appearance is similar to joined plastic straws.

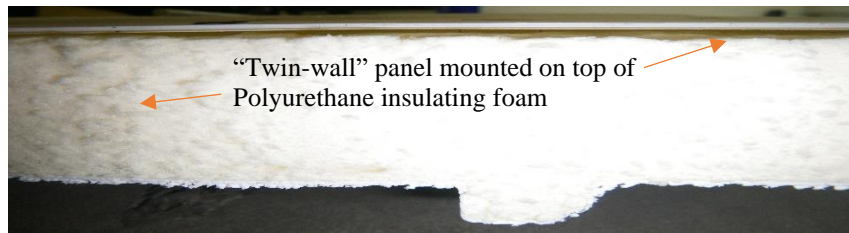
Fig 6.11 Twin-wall panel mounted on insulating foam viewed sideways.

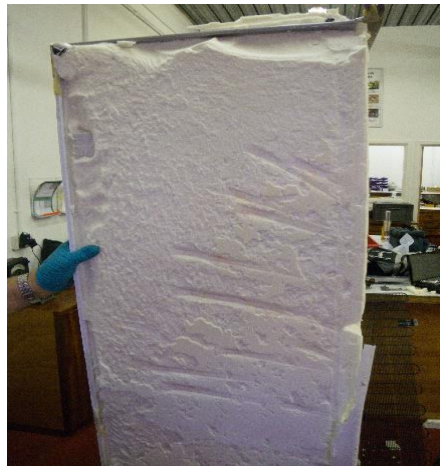
The early slab constructed internal insulation panels used in the UK have now been replaced by blown hydrocarbon foams – typically rigid polyurethane foam (Figure 6.13).

Figure 6-13 Removing the external metal sidewall reveals the hydrocarbon blown polyurethane foam beneath.

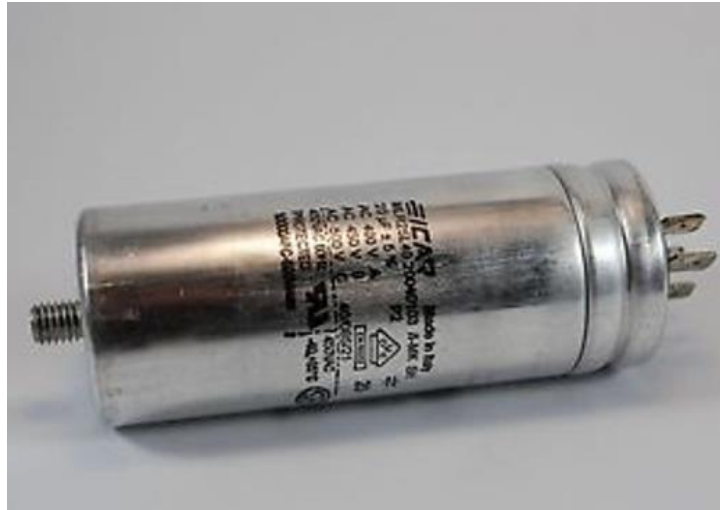
Figure 7.2 A fault tolerant protective S2 capacitor.

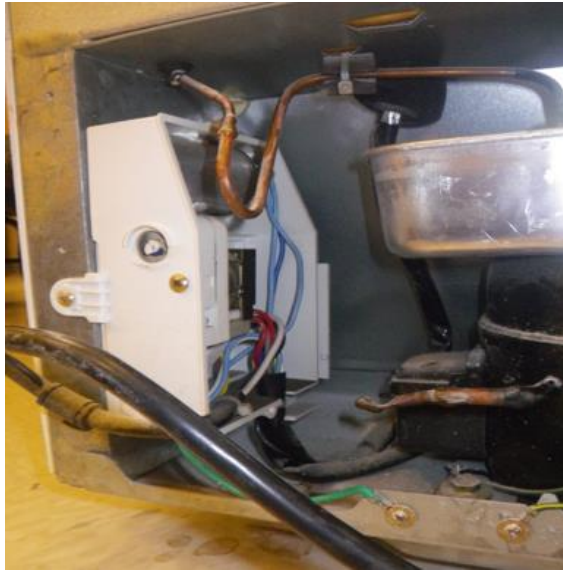
Figure 7.3 An American appliance with both the capacitor and the defrost timer switch mounted in a white fire resisting box within an all metal compressor housing and metal evaporator tray.

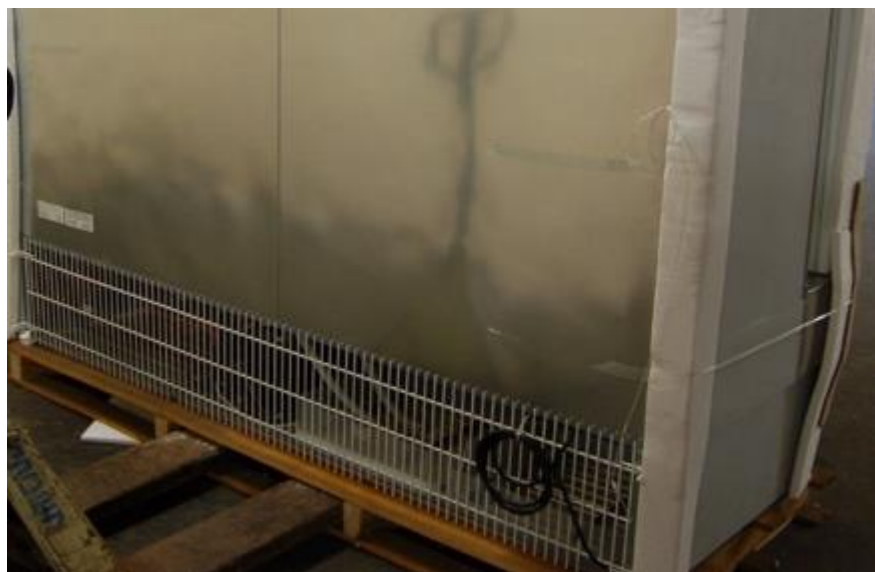
Grill guards, which are already used on many commercial fridge-freezers, could be introduced to inhibit rodent access to the interior of the fridge and the compressor housing (Figure 7.4).

Figure 7.4 Grill guard across compressor housing.

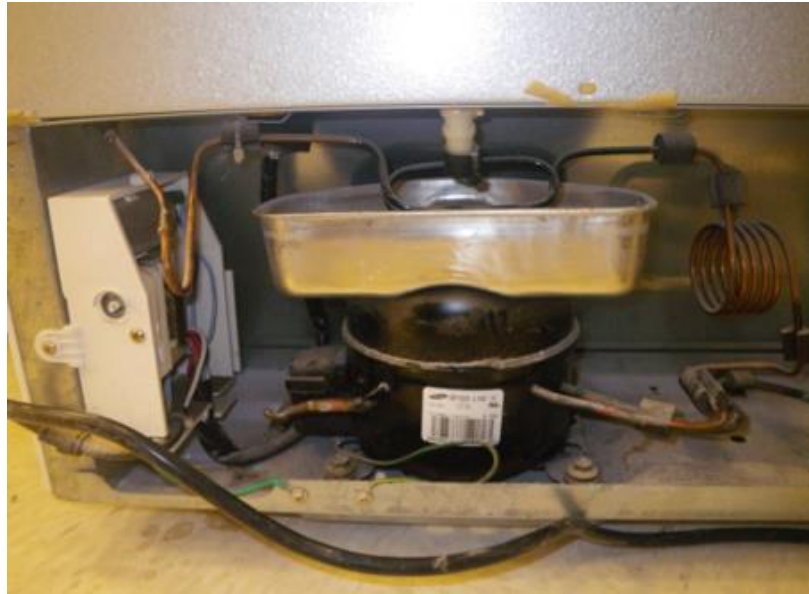
Evaporation trays should be constructed from metal or other non-combustible materials, as seen in figure 7.5 this would prevent them from igniting and assisting the spread a fire.

Figure 7.5 Example of a metal evaporation tray positioned above the compressor.

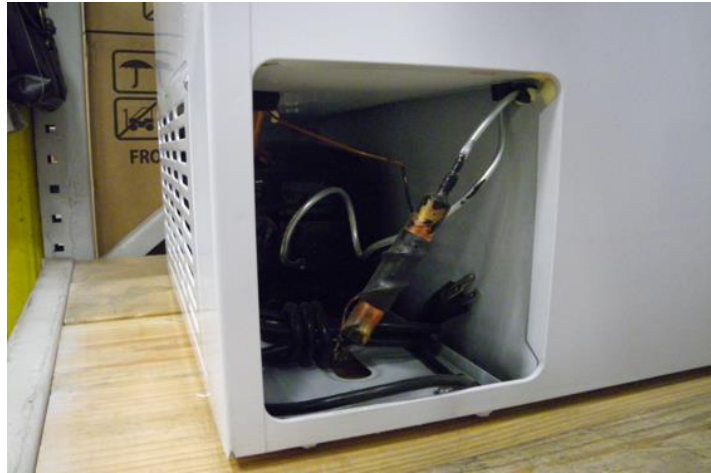
Figure 7.6 Example of using interior metal compartmentation to prevent fire spread from any potential component failure reaching the insulating material.

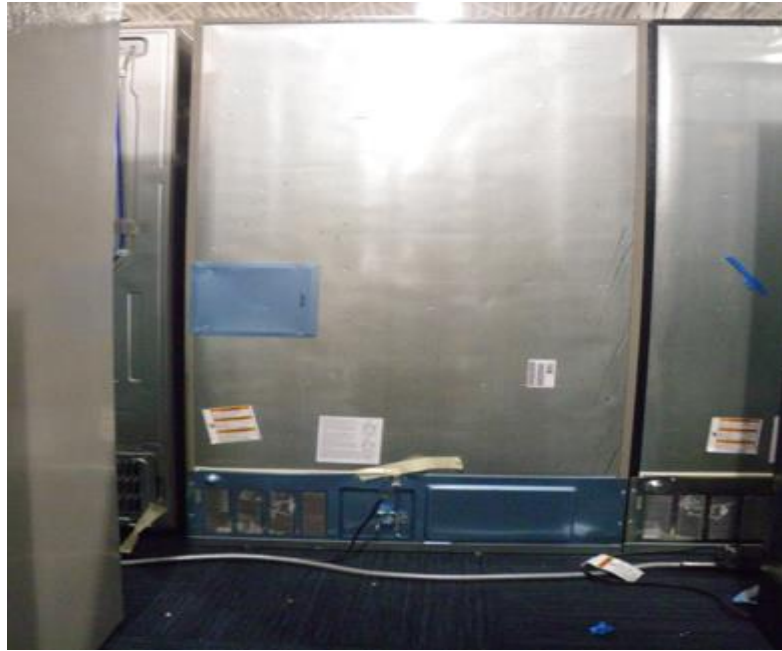
Figure 7.7 Example of a fridge-freezer appliance fitted with a metal back.
