Experimental analysis of 3D cracking in drying soils using Ground Penetrating Radar

Héctor U. Levatti¹, Pere C. Prat², Alberto Ledesma, Agustín Cuadrado & Josbel A. Cordero

Dept. of Civil and Environmental Engineering, UPC-BarcelonaTECH, Spain

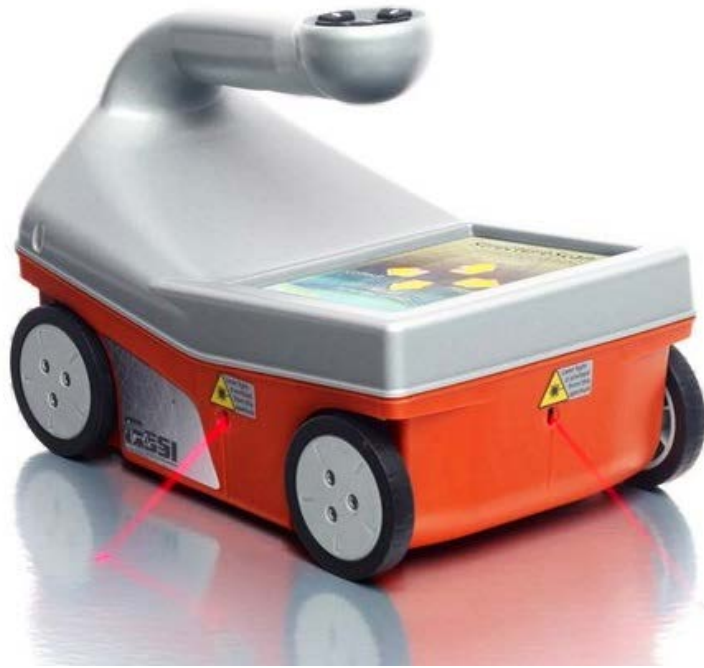
Figure 1 – The GSSI® *StructureScan Mini* device

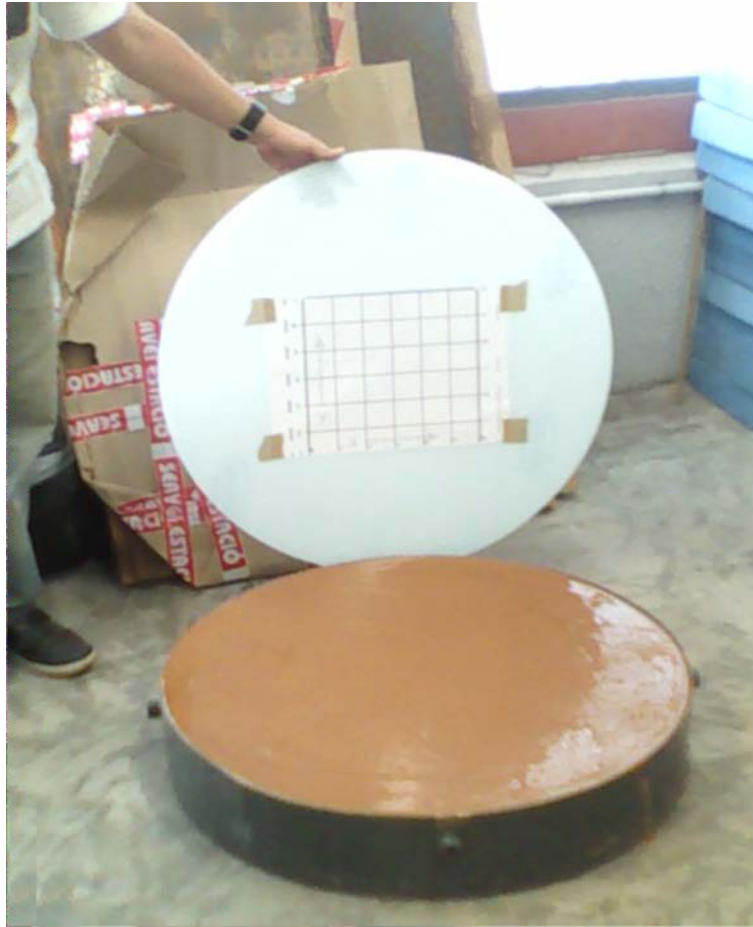
Figure 3 – Specimen and PMMA plate with grid to guide the device

Tests were carried out in the laboratory using the GPR on a drying soil specimen contained within a cylindrical tray of 80 cm in diameter and 10 cm high. Clay, initially in a slurry state, was poured into the tray and left to dry in the laboratory-controlled environment (air relative humidity of approximately 60% and temperature 24°C) during 36 days. The GPR device was used periodically to check for crack formation and propagation within the soil mass, and in order to calibrate the soil's electromagnetic properties. The use of the device requires a smooth, even surface on which it can slide. For that purpose, a one cm-thick poly(methyl methacrylate), or PMMA, circular plate was placed above the specimen.

A grid defining the line paths along which the device takes readings was affixed on top of the plate (see Figure 3). The grid was shaped as a 30 by 30 cm square defining **two sets of 7 orthogonal traverses** with a separation of 5 cm. Therefore, the soil portion of the specimen that was scanned by the GPR device was a square prism of dimensions 30 by 30 by 10 cm, located at the centre of the specimen. The nominal thickness of 10 cm, however, decreased during the drying process to 7 to 8 cm depending on the initial **moisture content** of the specimen. Figure 3 shows the initial stage of the soil inside the tray and the PMMA plate with the grid.

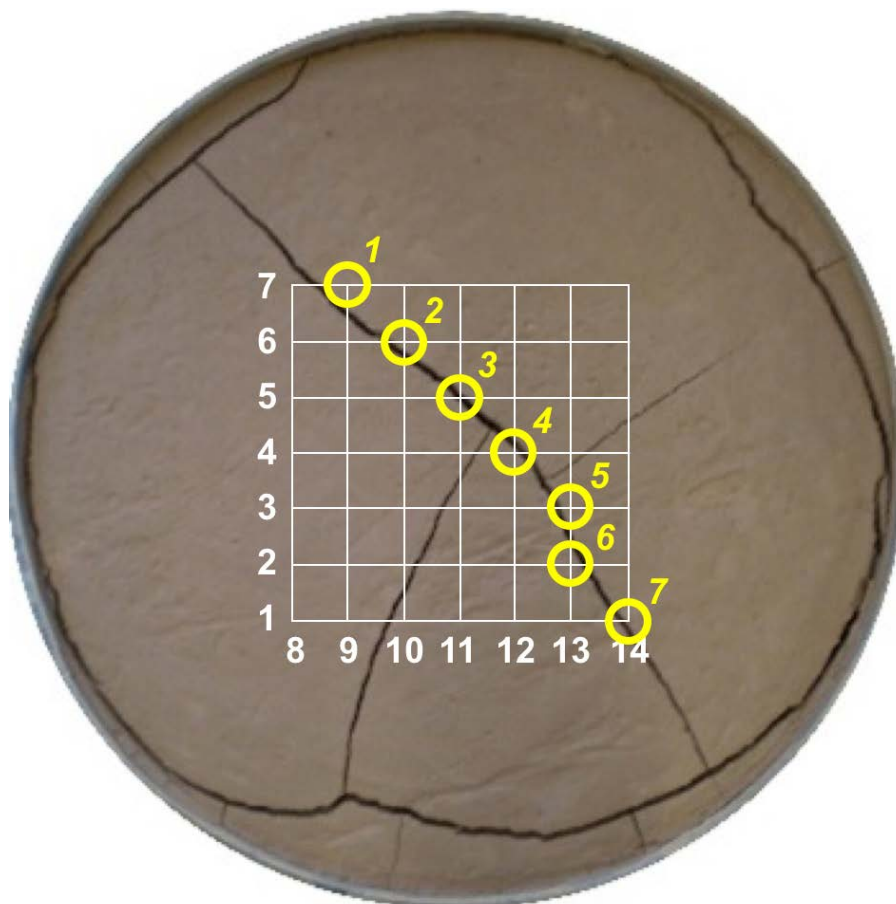
Figure 15 – Intersections at which the pseudo-3D images are obtained

As an example, focus is turned to the main crack that develops during the test (from the upper-left to the bottom-right corners). Figure 15 shows the crack and the points of interest where the pseudo-3D images will be generated. These images, at the seven intersection points, are shown in Figure 16. The sequence shows that the crack path is detected easily from the pseudo-3D images. Figure 17 shows the final crack pattern at the end of the test as seen from the top (airside, left) and the bottom (after dismantling, right). The image of the bottom surface

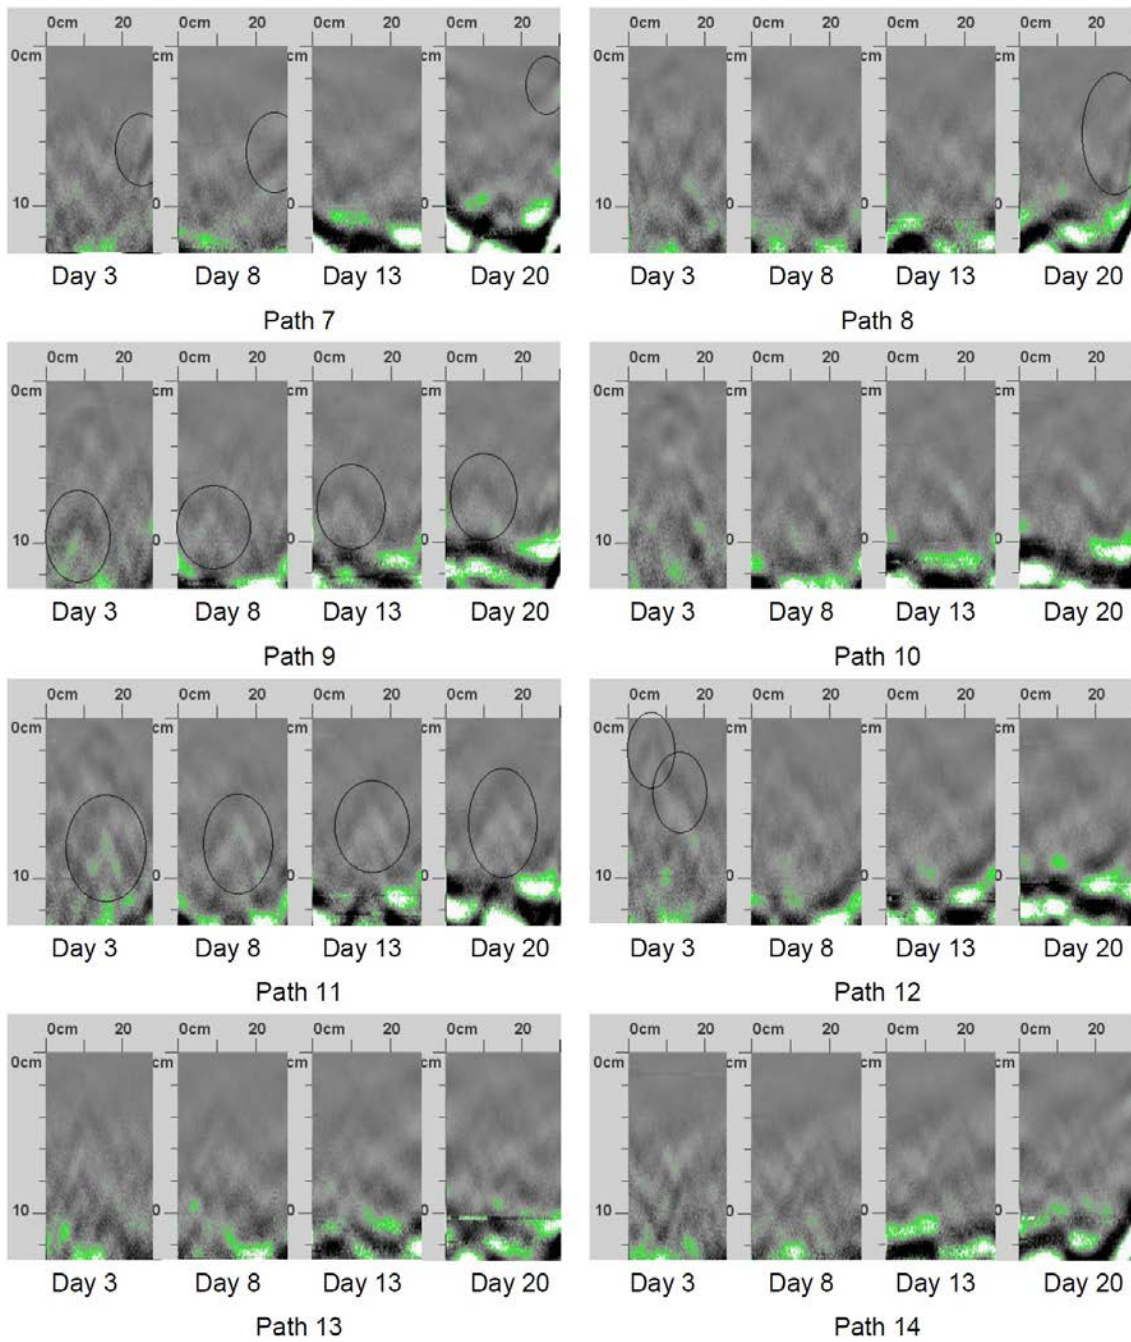
Figure 29 – Evolution of GPR profiles on paths 7-14 from day 3 to day 20

Figure 28 (paths 1 to 6) and Figure 29 (paths 7 to 14) show the GPR profiles obtained on days 3, 9, 13 and 20. Path 1 of day 3 shows, marked with a circle, what can be interpreted as a crack. However, this signal disappears in later profiles on days 8, 13 and 20. This was probably only a momentary discontinuity in the specimen's mass or a momentary heterogeneous distribution of water. Paths 2 and 3 show no cracks during the four days of auscultation. However, it is clear that the distribution of water is not totally homogeneous and the specimen's vertical shrinkage is detected as in the drying test (see previous section).

Path 7 (Figure 29) shows a crack that evolves from the middle height of the specimen (day 3) close to the end of the path, propagating towards the surface (on day 20) that seems to be the origin of crack 2 in Figure 27. Path 8 on day 20 shows crack 1 which on that day is already visible on the external surface of the specimen. Path 9 shows an internal crack that was not visible yet on the external surface. This crack evolved only partially from the bottom of the specimen and did not reach the external surface. Paths 10, 13 and 14 show no cracks for each of the four GPR scans but the profiles show heterogeneity probable produced by the three
